Access Compliance Report Public Rights-of-Way (Curb Ramps)

Intersection ID: 53743 Main Street: SMITH_RD Cross Street: CANTERBURY_CASTLE_DR Location: SE **Severity Score:** ADA ID: 243AA5E79298 Ramp Type: Perp Initial Pass/Fail: Fail **Overall Compliance: No** 22.5

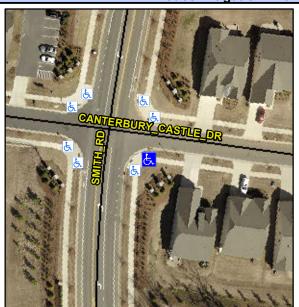
Field Measurements/Component Compliance						
Compliance Description		Data	Comp	liance Description	Data	
N/A	Ramp Length (in)	96.0	No	Ramp Slope (%)	8.7	
No	Ramp Width (in)	47.0	No	Ramp XSlope (%)	2.1	
N/A	Flare Type LT	N/A	N/A	Flare Type RT	N/A	
N/A	Flare Slope LT (%)	N/A	N/A	Flare Slope RT (%)	N/A	
N/A	Flare Traversable LT?	N/A	N/A	Flare Traversable RT?	N/A	
N/A	Landing Length (in)	N/A	N/A	DWS Provided?	N/A	
N/A	Landing Width (in)	N/A	N/A	DWS Contrast?	N/A	
N/A	Landing Slope (%)	N/A	N/A	DWS Length (in)	N/A	
N/A	Landing X Slope (%)	N/A	N/A	DWS Full Width?	N/A	
N/A	Landing Curb? (Y/N)	N/A	N/A	DWS Offset (in)	N/A	
N/A	Shared Landing?	N/A				
N/A	Gutter Ponding?	N/A	N/A	Gutter Slope (%)	N/A	
N/A	Gutter Lip Ht (in)	1.0	N/A	Gutter X Slope (%)	N/A	
N/A	Painted X Walk1?	No	N/A	Painted X Walk2?	N/A	
	X Walk 1 Direction	To NE		X Walk 2 Direction	N/A	
N/A	X Walk 1 Width (in)	N/A	N/A	X Walk 2 Width (in)	N/A	
	X Walk 1 Slope (%)	1.4		X Walk 2 Slope (%)	N/A

X Walk 1 X Slope (%)	4.3		X Walk 2 X Slope (%)	N/A	
N/A	Ramp inside XWalk1?	N/A	N/A	Ramp inside XWalk2?	N/A	
	Road Slope (%)	N/A	N/A	Clear Space?	N/A	
	Road X Slope (%)	N/A	N/A	Clear Space to XWalk (in)	N/A	
N/A	Any Obstructions?	N/A	N/A	Storm Grate/Utility Hazard?	N/A	
	Obstruction Type			Storm Grate/Utility Type		
		N/A			N/A	
			Yes	Surface Condition? (G/P)	Good

i ossible odlation				
Possible Solutions:	Co			
Remove & Replace Entire Ramp.				
	No			
	N/			
Surveyor Notes:	N/			
N/A	N/			
	N/			
	N/			
	N/			
PROW/ADA:	N/			
R304.5.1, R304.2.2, R304.5.3	N/			
, ,	N/			
	N/
