Access Compliance Report Public Rights-of-Way (Curb Ramps)

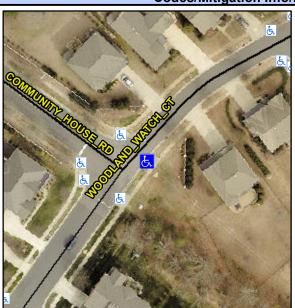
PROW/ADA:

Total Cost:	\$ 1850.00

Field Measurements/Component Compliance								
Compl	iance Description	Data	Comp	liance	Description	Data		
N/A	Ramp Length (in)	73.5	No	Ramp	Slope (%)	8.4		
Yes	Ramp Width (in)	48.0	No	Ramp	XSlope (%)	3.0		
N/A	Flare Type LT	N/A	N/A	Flare	Type RT	N/A		
N/A	Flare Slope LT (%)	N/A	N/A Flare Slope RT (%)			N/A		
N/A	Flare Traversable LT?	N/A	N/A Flare Traversable RT?			N/A		
N/A	Landing Length (in)	N/A	N/A	DWS	Provided?	N/A		
N/A	Landing Width (in)	N/A	N/A	DWS	Contrast?	N/A		
N/A	Landing Slope (%)	N/A	N/A	DWS	Length (in)	N/A		
N/A	Landing X Slope (%)	N/A	N/A	DWS	Full Width?	N/A		
N/A	Landing Curb? (Y/N)	N/A	N/A	DWS	Offset (in)	N/A		
N/A	Shared Landing?	N/A						
N/A	Gutter Ponding?	N/A	N/A	Gutte	r Slope (%)	N/A		
N/A	Gutter Lip Ht (in)	N/A	N/A	Gutte	r X Slope (%)	N/A		
N/A	Painted X Walk1?	No	N/A	Paint	ed X Walk2?	N/A		
	X Walk 1 Direction	To NW		X Wa	lk 2 Direction	N/A		
N/A	X Walk 1 Width (in)	N/A	N/A	X Wa	lk 2 Width (in)	N/A

Possible Solutions:

Not Found, R304.2.2, R304.5.3
