# Access Compliance Report

## Public Rights-of-Way

### (Curb Ramps)

Intersection ID: 15145	Main Street: DIANA_DR	Cross Street: IVERSON_WY	Location: S
ADA ID: 2462B334FC23	Ramp Type: Directional1	Initial Pass/Fail: Fail	Overall Compliance: No
Severity Score: 1.25			
Codes/Mitigation Info/Possible Solution		Field Measurements/Component Compliance

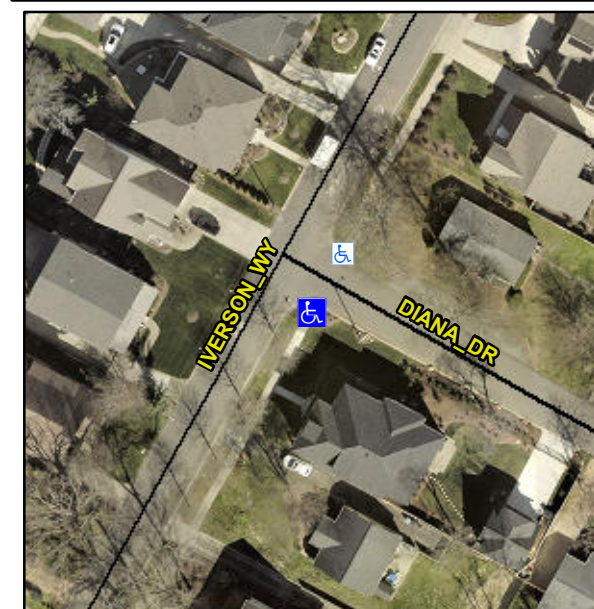
Compliance	Description	Data	Compliance	Description	Data
N/A	Ramp Length (in)	108.0	N/A	Grade Break?	N/A
Yes	Ramp Width (in)	48.0	N/A	Grade Break Slope (%)	0.0
Yes	Ramp Slope (%)	4.4	N/A	Grade Break XSlope (%)	0.0
No	Ramp XSlope (%)	3.0			
N/A	Flare Type LT	N/A	N/A	Flare Type RT	N/A
N/A	Flare Slope LT (%)	N/A	N/A	Flare Slope RT (%)	0.0
N/A	Flare Traversable LT?	N/A	N/A	Flare Traversable RT?	N/A
N/A	Landing Length (in)	0.0	N/A	DWS Provided?	N/A
N/A	Landing Width (in)	0.0	N/A	DWS Contrast?	N/A
N/A	Landing Slope (%)	0.0	N/A	DWS Length (in)	N/A
N/A	Landing X Slope (%)	0.0	N/A	DWS Full Width?	N/A
N/A	Landing Curb? (Y/N)	N/A	N/A	DWS Offset LT (in)	N/A
N/A	Shared Landing?	N/A	N/A	DWS Offset RT (in)	N/A
N/A	Gutter Ponding?	0.0	N/A	Gutter Slope (%)	N/A
N/A	Gutter Lip Ht (in)	0.0	N/A	Gutter X Slope (%)	N/A
N/A	Painted X Walk1?	No		Road Slope (%)	3.9
	X Walk 1 Direction	To N		Road X Slope (%)	1.0
	X Walk 1 Width (in)	N/A		Clear Space?	N/A

X Walk 1 Slope (%)	3.9	N/A	Clear Space to XWalk (in)	N/A
	X Walk 1 X Slope (%)	1.0	N/A	Storm Grate/Utility Hazard?	N/A
N/A	Ramp inside XWalk1?	N/A		Storm Grate/Utility Type	
N/A	Any Obstructions?	N/A			N/A
	Obstruction Type		Yes	Surface Condition? (G/P)	Good
			N/A	Curb Slope (%)	3.7

Possible Solutions:

**Remove & Replace Entire Ramp.**

**R304.5.3**

**\$ 1600.00**
