# Access Compliance Report

## Public Rights-of-Way

### (Curb Ramps)

Intersection ID: 53631	Main Street: PROVIDENCE_RD_WEST	Cross Street: BEACON_VALLEY_ST	Location: SE
ADA ID: 2465B2DB702E	Ramp Type: Perp	Initial Pass/Fail: Fail	Overall Compliance: No
Codes/Mitigation Info/Possible Solution		Field Measurements/Component Compliance	
Severity Score: 8.75

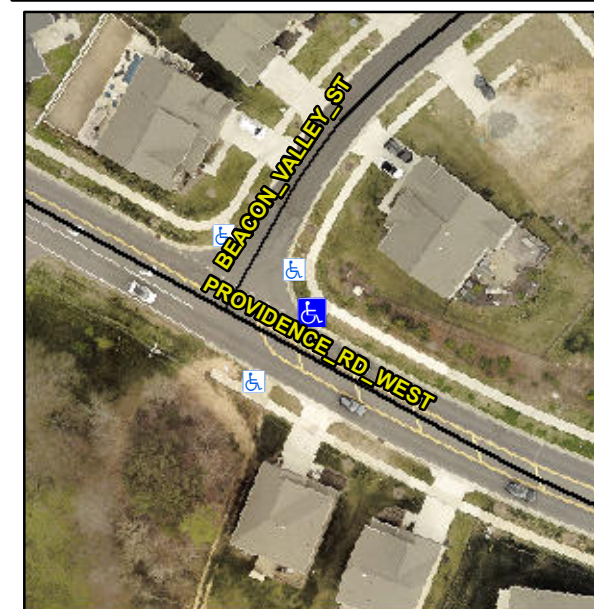
Compliance	Description	Data	Compliance	Description	Data
N/A	Ramp Length (in)	96.0	Yes	Ramp Slope (%)	5.0
No	Ramp Width (in)	47.0	Yes	Ramp XSlope (%)	0.5
N/A	Flare Type LT	N/A	N/A	Flare Type RT	N/A
N/A	Flare Slope LT (%)	N/A	N/A	Flare Slope RT (%)	N/A
N/A	Flare Traversable LT?	N/A	N/A	Flare Traversable RT?	N/A
N/A	Landing Length (in)	N/A	N/A	DWS Provided?	N/A
N/A	Landing Width (in)	N/A	N/A	DWS Contrast?	N/A
N/A	Landing Slope (%)	N/A	N/A	DWS Length (in)	N/A
N/A	Landing X Slope (%)	N/A	N/A	DWS Full Width?	N/A
N/A	Landing Curb? (Y/N)	N/A	N/A	DWS Offset (in)	N/A
N/A	Shared Landing?	N/A			
N/A	Gutter Ponding?	N/A	N/A	Gutter Slope (%)	N/A
N/A	Gutter Lip Ht (in)	N/A	N/A	Gutter X Slope (%)	N/A
N/A	Painted X Walk1?	No	N/A	Painted X Walk2?	N/A
	X Walk 1 Direction	To SW		X Walk 2 Direction	N/A
N/A	X Walk 1 Width (in)	N/A	N/A	X Walk 2 Width (in)	N/A
	X Walk 1 Slope (%)	7.3		X Walk 2 Slope (%)	N/A
	X Walk 1 X Slope (%)	0.2		X Walk 2 X Slope (%)	N/A

N/A	Ramp inside XWalk1?	N/A	N/A	Ramp inside XWalk2?	N/A
	Road Slope (%)	N/A	N/A	Clear Space?	N/A
	Road X Slope (%)	N/A	N/A	Clear Space to XWalk (in)	N/A
N/A	Any Obstructions?	N/A	N/A	Storm Grate/Utility Hazard?	N/A
	Obstruction Type			Storm Grate/Utility Type	
		N/A			N/A
			Yes	Surface Condition? (G/P)	Good

Possible Solutions:

**Remove & Replace Entire Ramp.**

**R304.5.1**

Total Cost: \$ 1850.00
