# Access Compliance Report

## Public Rights-of-Way

### (Curb Ramps)

Intersection ID: 11330	Main Street: FLAMINGO_AV	Cross Street: PALM_AV	Location: NW
ADA ID: 24732D39C552	Ramp Type: Perp	Initial Pass/Fail: Fail	Overall Compliance: No
Codes/Mitigation Info/Possible Solution		Field Measurements/Component Compliance	
Severity Score: 46.25

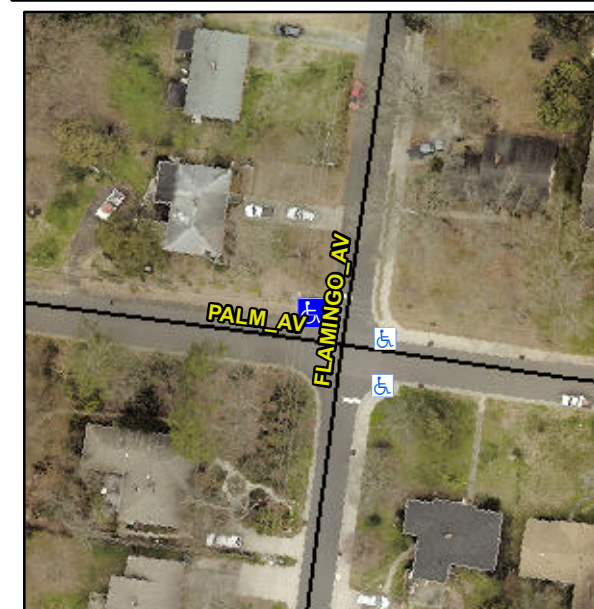
Compliance	Description	Data	Compliance	Description	Data
N/A	Ramp Length (in)	50.0	No	Ramp Slope (%)	11.6
No	Ramp Width (in)	45.0	No	Ramp XSlope (%)	8.8
N/A	Flare Type LT	N/A	N/A	Flare Type RT	N/A
N/A	Flare Slope LT (%)	N/A	N/A	Flare Slope RT (%)	N/A
N/A	Flare Traversable LT?	N/A	N/A	Flare Traversable RT?	N/A
N/A	Landing Length (in)	N/A	N/A	DWS Provided?	N/A
N/A	Landing Width (in)	N/A	N/A	DWS Contrast?	N/A
N/A	Landing Slope (%)	N/A	N/A	DWS Length (in)	N/A
N/A	Landing X Slope (%)	N/A	N/A	DWS Full Width?	N/A
N/A	Landing Curb? (Y/N)	N/A	N/A	DWS Offset (in)	N/A
N/A	Shared Landing?	N/A			
N/A	Gutter Ponding?	N/A	N/A	Gutter Slope (%)	N/A
N/A	Gutter Lip Ht (in)	1.5	N/A	Gutter X Slope (%)	N/A
N/A	Painted X Walk1?	No	N/A	Painted X Walk2?	N/A
	X Walk 1 Direction	To E		X Walk 2 Direction	N/A
N/A	X Walk 1 Width (in)	N/A	N/A	X Walk 2 Width (in)	N/A
	X Walk 1 Slope (%)	8.4		X Walk 2 Slope (%)	N/A
	X Walk 1 X Slope (%)	4.7		X Walk 2 X Slope (%)	N/A

N/A	Ramp inside XWalk1?	N/A	N/A	Ramp inside XWalk2?	N/A
	Road Slope (%)	N/A	N/A	Clear Space?	N/A
	Road X Slope (%)	N/A	N/A	Clear Space to XWalk (in)	N/A
N/A	Any Obstructions?	N/A	N/A	Storm Grate/Utility Hazard?	N/A
	Obstruction Type			Storm Grate/Utility Type	
		N/A			N/A
			Yes	Surface Condition? (G/P)	Good

Possible Solutions:

**Remove & Replace Entire Ramp.**
