Access Compliance Report

Public Rights-of-Way

(Curb Ramps)

| Intersection ID: 11739 | Main Street: W_9TH_ST | Cross Street: N_CHURCH_ST | Location: | N |

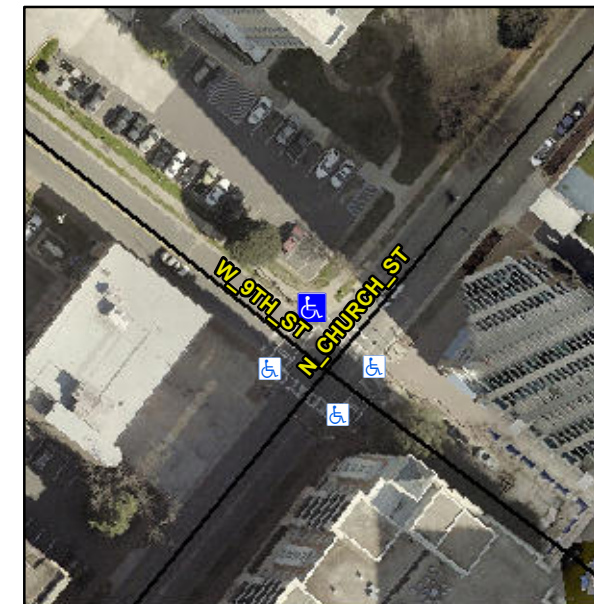
| ADA ID: 247481459A51 | Ramp Type: PerpDiag | Initial Pass/Fail: Fail | Overall Compliance: No | Severity Score: 22.5 |

Not Found, R304.5.1, R304.2.2

| Compliance | Description | Data | Compliance | Description | Data |
|---|---|---|---|---|---|
| N/A | Ramp Length (in) | 60.0 | No | Ramp Slope (%) | 9.9 |
| No | Ramp Width (in) | 36.0 | Yes | Ramp XSlope (%) | 3.9 |

Possible Solutions:

Remove & Replace Curb Ramp With Two New Directional Ramps or Equivalent.
