# Access Compliance Report

## Public Rights-of-Way

### (Curb Ramps)

Intersection ID: 3907	Main Street: ALNWICK_CT	Cross Street: COPPERPLATE_RD	Location: W
ADA ID: 2477EA878507	Ramp Type: Perp	Initial Pass/Fail: Fail	Overall Compliance: No
Severity Score: 1.25			
Codes/Mitigation Info/Possible Solution		Field Measurements/Component Compliance

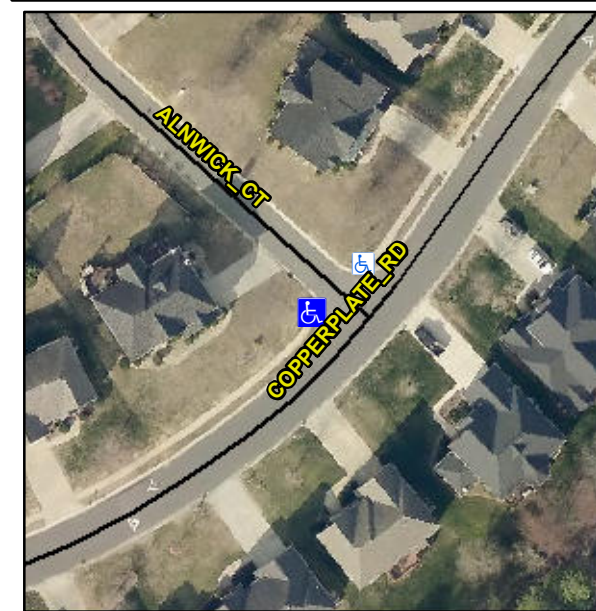
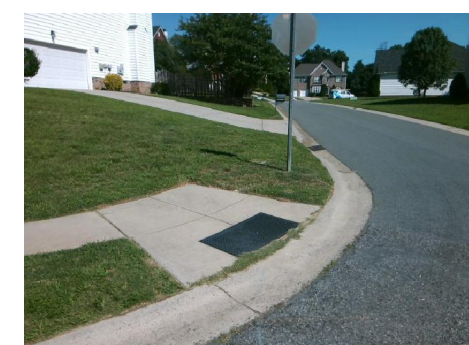
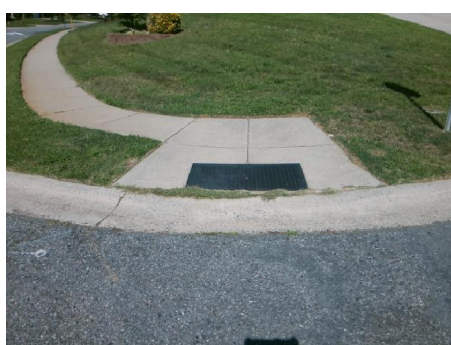
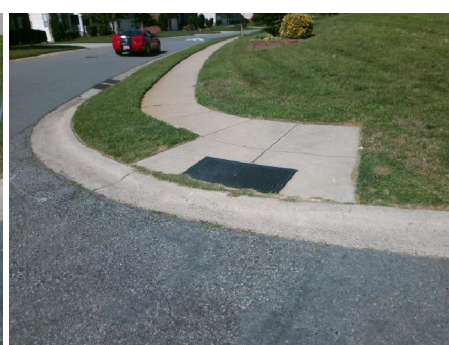
**Not Found, R304.5.3**

Compliance	Description	Data	Compliance	Description	Data
N/A	Ramp Length (in)	49.0	Yes	Ramp Slope (%)	6.1
Yes	Ramp Width (in)	48.0	No	Ramp XSlope (%)	3.6
N/A	Flare Type LT	N/A	N/A	Flare Type RT	N/A
N/A	Flare Slope LT (%)	N/A	N/A	Flare Slope RT (%)	N/A
N/A	Flare Traversable LT?	N/A	N/A	Flare Traversable RT?	N/A
N/A	Landing Length (in)	N/A	N/A	DWS Provided?	N/A
N/A	Landing Width (in)	N/A	N/A	DWS Contrast?	N/A
N/A	Landing Slope (%)	N/A	N/A	DWS Length (in)	N/A
N/A	Landing X Slope (%)	N/A	N/A	DWS Full Width?	N/A
N/A	Landing Curb? (Y/N)	N/A	N/A	DWS Offset (in)	N/A
N/A	Shared Landing?	N/A			
N/A	Gutter Ponding?	N/A	N/A	Gutter Slope (%)	N/A
N/A	Gutter Lip Ht (in)	N/A	N/A	Gutter X Slope (%)	N/A
N/A	Painted X Walk1?	No	N/A	Painted X Walk2?	N/A
	X Walk 1 Direction	To NE		X Walk 2 Direction	N/A
N/A	X Walk 1 Width (in)	N/A	N/A	X Walk 2 Width (in)	N/A
	X Walk 1 Slope (%)	3.7		X Walk 2 Slope (%)	N/A
	X Walk 1 X Slope (%)	1.6		X Walk 2 X Slope (%)	N/A

N/A	Ramp inside XWalk1?	N/A	N/A	Ramp inside XWalk2?	N/A
	Road Slope (%)	N/A	N/A	Clear Space?	N/A
	Road X Slope (%)	N/A	N/A	Clear Space to XWalk (in)	N/A
N/A	Any Obstructions?	N/A	N/A	Storm Grate/Utility Hazard?	N/A
	Obstruction Type			Storm Grate/Utility Type	
		N/A			N/A
			Yes	Surface Condition? (G/P)	Good

**Remove & Replace Entire Ramp.**

Total Cost: \$ 1850.00
