# Access Compliance Report

## Public Rights-of-Way

### (Curb Ramps)

Intersection ID: 20975	Main Street: DELSHIRE_LN	Cross Street: SANDY_PORTER_RD	Location: W
ADA ID: 247871B1E40B	Ramp Type: Directional1	Initial Pass/Fail: Fail	Overall Compliance: No
		Severity Score: 1.25

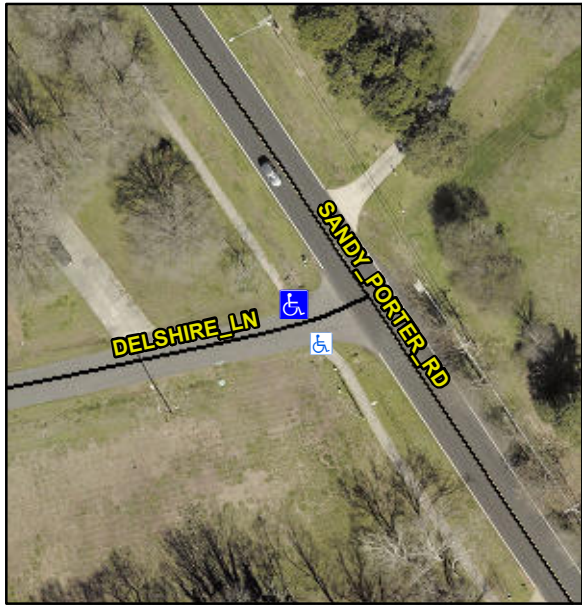
Possible Solutions:		<b>Compliance</b>			<b>Description</b>			<b>Data</b>	
	<b>Remove &amp; Replace Entire Ramp.</b>		<b>N/A</b>	Ramp Length (in)	<b>66.0</b>	<b>N/A</b>	Grade Break?	<b>N/A</b>		
			<b>Yes</b>	Ramp Width (in)	<b>64.0</b>	<b>N/A</b>	Grade Break Slope (%)	<b>0.0</b>		
			<b>Yes</b>	Ramp Slope (%)	<b>2.7</b>	<b>N/A</b>	Grade Break XSlope (%)	<b>0.0</b>		
			<b>No</b>	Ramp XSlope (%)	<b>3.3</b>					
			<b>N/A</b>	Flare Type LT	<b>N/A</b>	<b>N/A</b>	Flare Type RT	<b>N/A</b>		
			<b>N/A</b>	Flare Slope LT (%)	<b>N/A</b>	<b>N/A</b>	Flare Slope RT (%)	<b>0.0</b>		
			<b>N/A</b>	Flare Traversable LT?	<b>N/A</b>	<b>N/A</b>	Flare Traversable RT?	<b>N/A</b>		
			<b>N/A</b>	Landing Length (in)	<b>0.0</b>	<b>N/A</b>	DWS Provided?	<b>N/A</b>		
			<b>N/A</b>	Landing Width (in)	<b>0.0</b>	<b>N/A</b>	DWS Contrast?	<b>N/A</b>

<b>N/A</b>	Landing Slope (%)	<b>0.0</b>	<b>N/A</b>	DWS Length (in)	<b>N/A</b>			
		<b>N/A</b>	Landing X Slope (%)	<b>0.0</b>	<b>N/A</b>	DWS Full Width?	<b>N/A</b>			
		<b>N/A</b>	Landing Curb? (Y/N)	<b>N/A</b>	<b>N/A</b>	DWS Offset LT (in)	<b>N/A</b>			
		<b>N/A</b>	Shared Landing?	<b>N/A</b>	<b>N/A</b>	DWS Offset RT (in)	<b>N/A</b>			
		<b>N/A</b>	Gutter Ponding?	<b>0.0</b>	<b>N/A</b>	Gutter Slope (%)	<b>N/A</b>			
		<b>N/A</b>	Gutter Lip Ht (in)	<b>0.0</b>	<b>N/A</b>	Gutter X Slope (%)	<b>N/A</b>			
		<b>N/A</b>	Painted X Walk1?	<b>No</b>		Road Slope (%)	<b>1.4</b>			
			X Walk 1 Direction	<b>To SE</b>		Road X Slope (%)	<b>2.7</b>			
			X Walk 1 Width (in)	<b>N/A</b>		Clear Space?	<b>N/A</b>			
			X Walk 1 Slope (%)	<b>1.4</b>	<b>N/A</b>	Clear Space to XWalk (in)	<b>N/A</b>			
			X Walk 1 X Slope (%)	<b>2.7</b>	<b>N/A</b>	Storm Grate/Utility Hazard?	<b>N/A</b>			
		<b>N/A</b>	Ramp inside XWalk1?	<b>N/A</b>		Storm Grate/Utility Type

<b>N/A</b>	Any Obstructions?	<b>N/A</b>			<b>N/A</b>			
			Obstruction Type		<b>Yes</b>	Surface Condition? (G/P)	<b>Good</b>			
					<b>N/A</b>	Curb Slope (%)	<b>5.7</b>			
Surveyor Notes:										
<b>N/A</b>										
PROW/ADA:										
<b>R304.5.3</b>										
Total Cost:		<b>\$</b>	<b>1600.00</b>							
Street 1 Name		<b>DELSHIRE LN</b>								
Stop Condition-Street 1		<b>StopSign</b>								
Street 2 Name		<b>N/A</b>								
Stop Condition-Street 2		<b>N/A</b>
