# Access Compliance Report

## Public Rights-of-Way

### (Curb Ramps)

| Intersection ID: 13661 | Main Street: CENTRAL_AV | Cross Street: FLYNNWOOD_DR | Location: NW |

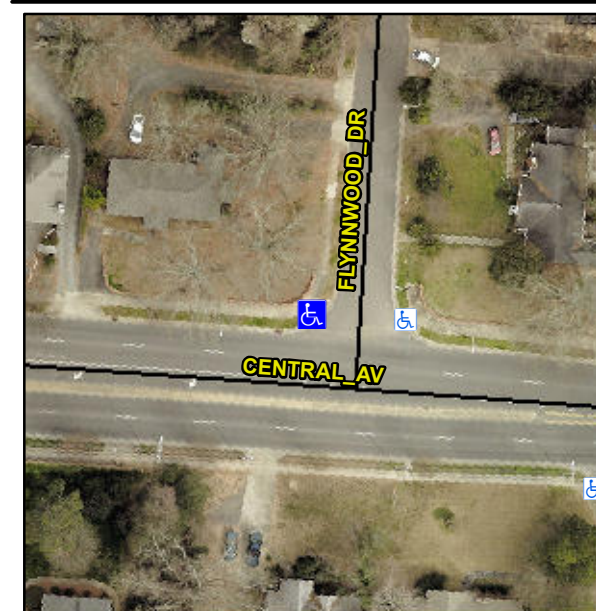
| ADA ID: 247A5739392B | Ramp Type: Perp | Initial Pass/Fail: Fail | Overall Compliance: No |
| Severity Score: 22.5 | | | |

**Not Found, R304.5.1, R304.2.2, R304.5.3**

| Compliance | Description | Data | Compliance | Description | Data |
|---|---|---|---|---|---|
| N/A | Ramp Length (in) | 56.0 | No | Ramp Slope (%) | 9.3 |
| No | Ramp Width (in) | 38.0 | No | Ramp XSlope (%) | 2.8 |

**Remove & Replace Entire Ramp.**

Total Cost: \$ 1850.00
