Access Compliance Report

Public Rights-of-Way

(Curb Ramps)

Intersection ID: 10039363	Main Street: SYDENHAM_CT	Cross Street: N/A	Location: SW
ADA ID: 2481473F4FD9	Ramp Type: Perp	Initial Pass/Fail: Fail	Overall Compliance: No
Codes/Mitigation Info/Possible Solution		Field Measurements/Component Compliance	
Severity Score: 25

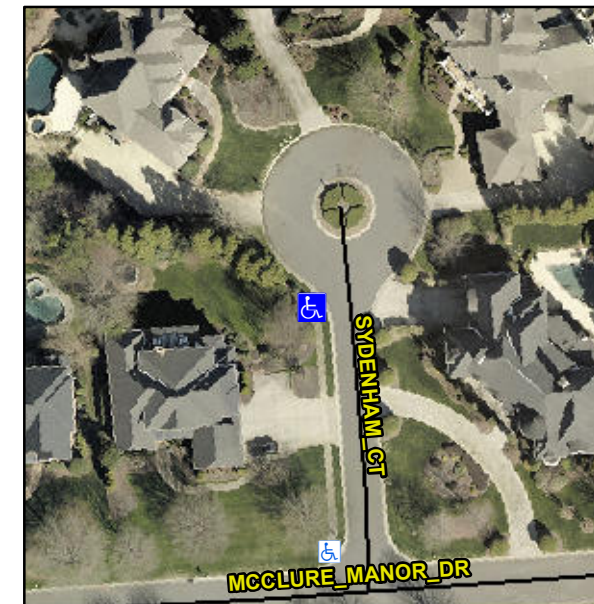
Compliance	Description	Data	Compliance	Description	Data
N/A	Ramp Length (in)	49.0	No	Ramp Slope (%)	9.0
Yes	Ramp Width (in)	48.0	No	Ramp XSlope (%)	6.0
N/A	Flare Type LT	N/A	N/A	Flare Type RT	N/A
N/A	Flare Slope LT (%)	N/A	N/A	Flare Slope RT (%)	N/A
N/A	Flare Traversable LT?	N/A	N/A	Flare Traversable RT?	N/A
N/A	Landing Length (in)	N/A	N/A	DWS Provided?	N/A
N/A	Landing Width (in)	N/A	N/A	DWS Contrast?	N/A
N/A	Landing Slope (%)	N/A	N/A	DWS Length (in)	N/A
N/A	Landing X Slope (%)	N/A	N/A	DWS Full Width?	N/A
N/A	Landing Curb? (Y/N)	N/A	N/A	DWS Offset (in)	N/A
N/A	Shared Landing?	N/A			
N/A	Gutter Ponding?	N/A	N/A	Gutter Slope (%)	N/A
N/A	Gutter Lip Ht (in)	N/A	N/A	Gutter X Slope (%)	N/A
N/A	Painted X Walk1?	No	N/A	Painted X Walk2?	N/A
	X Walk 1 Direction	To E		X Walk 2 Direction	N/A
N/A	X Walk 1 Width (in)	N/A	N/A	X Walk 2 Width (in)	N/A
	X Walk 1 Slope (%)	0.3		X Walk 2 Slope (%)	N/A
	X Walk 1 X Slope (%)	5.6		X Walk 2 X Slope (%)	N/A

N/A	Ramp inside XWalk1?	N/A	N/A	Ramp inside XWalk2?	N/A
	Road Slope (%)	N/A	N/A	Clear Space?	N/A
	Road X Slope (%)	N/A	N/A	Clear Space to XWalk (in)	N/A
N/A	Any Obstructions?	N/A	N/A	Storm Grate/Utility Hazard?	N/A
	Obstruction Type			Storm Grate/Utility Type	
		N/A			N/A
			Yes	Surface Condition? (G/P)	Good

Remove & Replace Entire Ramp.
