Access Compliance Report Public Rights-of-Way (Curb Ramps)

Intersection ID: 12619 Main Street: ALICE_E_ORR_DR Cross Street: SHAMROCK_DR Location: E

ADA ID: 2483B48ABF12 Ramp Type: PerpDiag Initial Pass/Fail: Fail Overall Compliance: No Severity Score: 22.5

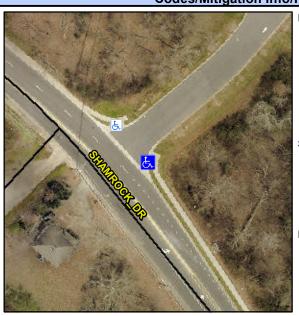
Field Measurements/Component Compliance						
Compliance Description			Data	Com	oliance Description	Data
N	l/A	Ramp Length (in)	46.5	No	Ramp Slope (%)	10.5
N	lo	Ramp Width (in)	46.0	No	Ramp XSlope (%)	3.9
N	/ A	Flare Type LT	N/A	N/A	Flare Type RT	N/A
N	I/A	Flare Slope LT (%)	N/A	N/A	Flare Slope RT (%)	N/A
N	I/A	Flare Traversable LT?	N/A	N/A	Flare Traversable RT?	N/A
N	l/A	Landing Length (in)	N/A	N/A	DWS Provided?	N/A
N	l/A	Landing Width (in)	N/A	N/A	DWS Contrast?	N/A
N	l/A	Landing Slope (%)	N/A	N/A	DWS Length (in)	N/A
N	l/A	Landing X Slope (%)	N/A	N/A	DWS Full Width?	N/A
N	l/A	Landing Curb? (Y/N)	N/A	N/A	DWS Offset (in)	N/A
N	l/A	Shared Landing?	N/A			
N	l/A	Gutter Ponding?	N/A	N/A	Gutter Slope (%)	N/A
N	/ A	Gutter Lip Ht (in)	N/A	N/A	Gutter X Slope (%)	N/A
N	l/A	Painted X Walk1?	No	N/A	Painted X Walk2?	No
		X Walk 1 Direction	To NW		X Walk 2 Direction	To SW
N	l/A	X Walk 1 Width (in)	N/A	N/A	X Walk 2 Width (in)	N/A

X Walk 1 Slope (%)	1.4		X Walk 2 Slope (%)	3.3
		X Walk 1 X Slope (%)	2.2		X Walk 2 X Slope (%)	4.1
N	l/A	Ramp inside XWalk1?	N/A	N/A	Ramp inside XWalk2?	N/A
		Road Slope (%)	2.2	N/A	Clear Space?	N/A
		Road X Slope (%)	0.9	N/A	Clear Space to XWalk (in)	N/A
N	I/A	Any Obstructions?	N/A	N/A	Storm Grate/Utility Hazard?	N/A
		Obstruction Type			Storm Grate/Utility Type	
			N/A			N/A
				Yes	Surface Condition? (G/P)	Good
fact to

ENTRANCE StopSign SHAMROCK DR None Possible Solutions:

Remove & Replace Curb Ramp With
Two New Directional Ramps or
Equivalent.

PROW/ADA:
R304.5.1, R304.2.2, R304.5.3
