# Access Compliance Report

## Public Rights-of-Way

### (Curb Ramps)

| Intersection ID: 30263 | Main Street: BLYTHEDALE_DR | Cross Street: FORTESCUE_DR | Location: S |

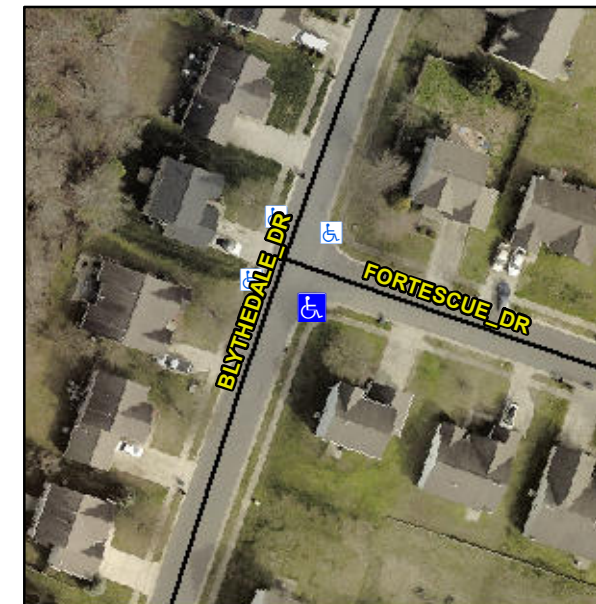
**Not Found, R304.2.1, R304.2.2-Perp, R304.3.2-Para, R305.2**

| Compliance | Description | Data | Compliance | Description | Data |
|---|---|---|---|---|---|
| No | Landing Length (in) | 44.0 | Yes | DWS Provided? | Yes |
| No | Landing Slope (%) | 5.5 | Yes | DWS Length (in) | 25.5 |
| N/A | Landing Curb? (Y/N) | No | No | DWS Offset (in) | 3.0 |

**Remove & Replace Curb Ramp With Two New Directional Ramps or Equivalent.**
