# Access Compliance Report

## Public Rights-of-Way

### (Curb Ramps)

Intersection ID: 10014838	Main Street: THE_PLAZA	Cross Street: N/A	Location: NW
ADA ID: 24866E370FC0	Ramp Type: PerpDiag	Initial Pass/Fail: Fail	Overall Compliance: No
		Severity Score: 12.5

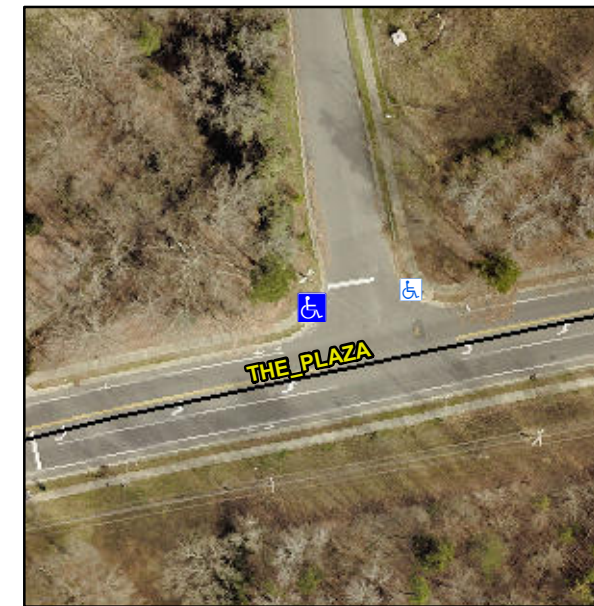
**Not Found, R304.5.3**

Compliance	Description	Data	Compliance	Description	Data
N/A	Ramp Length (in)	107.0	Yes	Ramp Slope (%)	5.4
Yes	Ramp Width (in)	48.0	No	Ramp XSlope (%)	6.6
N/A	Flare Type LT	N/A	N/A	Flare Type RT	N/A
N/A	Flare Slope LT (%)	N/A	N/A	Flare Slope RT (%)	N/A
N/A	Flare Traversable LT?	N/A	N/A	Flare Traversable RT?	N/A
N/A	Landing Length (in)	N/A	N/A	DWS Provided?	N/A
N/A	Landing Width (in)	N/A	N/A	DWS Contrast?	N/A
N/A	Landing Slope (%)	N/A	N/A	DWS Length (in)	N/A
N/A	Landing X Slope (%)	N/A	N/A	DWS Full Width?	N/A
N/A	Landing Curb? (Y/N)	N/A	N/A	DWS Offset (in)	N/A
N/A	Shared Landing?	N/A			
N/A	Gutter Ponding?	N/A	N/A	Gutter Slope (%)	N/A
N/A	Gutter Lip Ht (in)	N/A	N/A	Gutter X Slope (%)	N/A
N/A	Painted X Walk1?	No	N/A	Painted X Walk2?	No
	X Walk 1 Direction	To S		X Walk 2 Direction	To E
N/A	X Walk 1 Width (in)	N/A	N/A	X Walk 2 Width (in)	N/A
	X Walk 1 Slope (%)	0.9		X Walk 2 Slope (%)	4.9
	X Walk 1 X Slope (%)	5.0		X Walk 2 X Slope (%)	1.1

N/A	Ramp inside XWalk1?	N/A	N/A	Ramp inside XWalk2?	N/A
	Road Slope (%)	4.1	N/A	Clear Space?	N/A
	Road X Slope (%)	2.1	N/A	Clear Space to XWalk (in)	N/A
N/A	Any Obstructions?	N/A	N/A	Storm Grate/Utility Hazard?	N/A
	Obstruction Type			Storm Grate/Utility Type	
		N/A			N/A
		Yes		Surface Condition? (G/P)	Good

**Remove & Replace Curb Ramp With Two New Directional Ramps or Equivalent.**

Total Cost: \$ 3200.00
