## **Access Compliance Report Public Rights-of-Way** (Curb Ramps)

Intersection ID: 25500 Main Street: PINEVILLE-MATTHEWS RD **Cross Street: STRAWBERRY LN** Location: SW ADA ID: 24897E0A5A3F Ramp Type: PerpDiag Initial Pass/Fail: Fail **Overall Compliance: No** Severity Score: 21.25

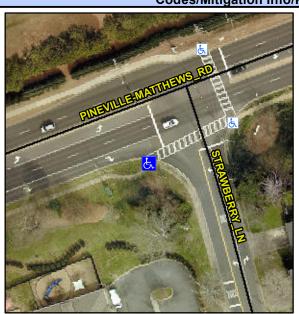
Field Measurements/Component Compliance					
Compliance Description		Data	Compliance Description		Data
N/A	Ramp Length (in)	59.0	No	Ramp Slope (%)	8.7
No	Ramp Width (in)	42.0	Yes	Ramp XSlope (%)	1.1
N/A	Flare Type LT	N/A	N/A	Flare Type RT	N/A
N/A	Flare Slope LT (%)	N/A	N/A	Flare Slope RT (%)	N/A
N/A	Flare Traversable LT?	N/A	N/A	Flare Traversable RT?	N/A
N/A	Landing Length (in)	N/A	N/A	DWS Provided?	N/A
N/A	Landing Width (in)	N/A	N/A	DWS Contrast?	N/A
N/A	Landing Slope (%)	N/A	N/A	DWS Length (in)	N/A
N/A	Landing X Slope (%)	N/A	N/A	DWS Full Width?	N/A
N/A	Landing Curb? (Y/N)	N/A	N/A	DWS Offset (in)	N/A
N/A	Shared Landing?	N/A			
N/A	Gutter Ponding?	N/A	N/A	Gutter Slope (%)	N/A
N/A	Gutter Lip Ht (in)	N/A	N/A	Gutter X Slope (%)	N/A
N/A	Painted X Walk1?	Yes	N/A	Painted X Walk2?	No
	X Walk 1 Direction	To NE		X Walk 2 Direction	To N
N/A	X Walk 1 Width (in)	107.0	N/A	X Walk 2 Width (in)	N/A
	X Walk 1 Slope (%)	1.9		X Walk 2 Slope (%)	2.5

X Walk 1 X Slope (%)	2.0		X Walk 2 X Slope (%)	2.8
N/A	Ramp inside XWalk1?	Yes	N/A	Ramp inside XWalk2?	N/A
	Road Slope (%)	0.7	N/A	Clear Space?	N/A
	Road X Slope (%)	3.0	N/A	Clear Space to XWalk (in)	N/A
N/A	Any Obstructions?	N/A	N/A	Storm Grate/Utility Hazard?	N/A
	Obstruction Type			Storm Grate/Utility Type	
		N/A			N/A
			Yes	Surface Condition? (G/P)	Good
NATIONAL PROPERTY OF	WWW. and the second sec

Possible Solutions: **Remove & Replace Curb Ramp With Two New Directional Ramps or** Equivalent. Surveyor Notes: N/A PROW/ADA: Not Found, R304.5.1, R304.2.2
