# Access Compliance Report

## Public Rights-of-Way

### (Curb Ramps)

Intersection ID: N/A	Main Street: CANTERBURY_CASTLE_DR	Cross Street: BELVEDERE_CASTLE_DR	Location: S
ADA ID: 249149357193	Ramp Type: Perp	Initial Pass/Fail: Fail	Overall Compliance: No
Codes/Mitigation Info/Possible Solution		Field Measurements/Component Compliance	
Severity Score: 21.25

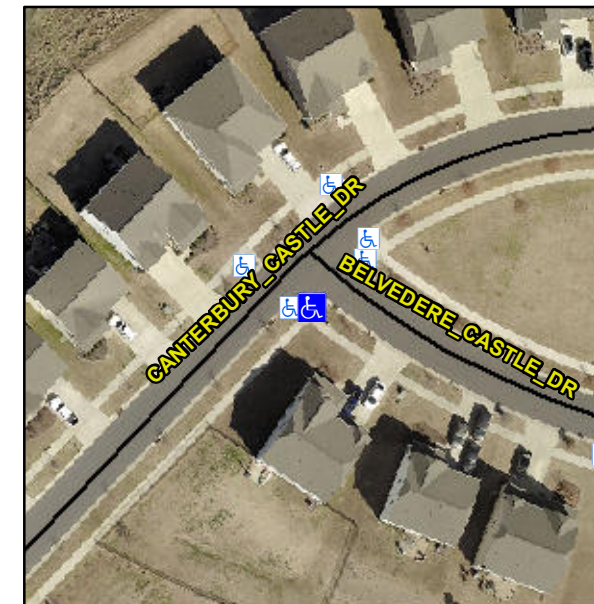
Compliance	Description	Data	Compliance	Description	Data
N/A	Ramp Length (in)	98.0	Yes	Ramp Slope (%)	7.4
No	Ramp Width (in)	47.0	No	Ramp XSlope (%)	5.3
N/A	Flare Type LT	N/A	N/A	Flare Type RT	N/A
N/A	Flare Slope LT (%)	N/A	N/A	Flare Slope RT (%)	N/A
N/A	Flare Traversable LT?	N/A	N/A	Flare Traversable RT?	N/A
N/A	Landing Length (in)	N/A	N/A	DWS Provided?	N/A
N/A	Landing Width (in)	N/A	N/A	DWS Contrast?	N/A
N/A	Landing Slope (%)	N/A	N/A	DWS Length (in)	N/A
N/A	Landing X Slope (%)	N/A	N/A	DWS Full Width?	N/A
N/A	Landing Curb? (Y/N)	N/A	N/A	DWS Offset (in)	N/A
N/A	Shared Landing?	N/A			
N/A	Gutter Ponding?	N/A	N/A	Gutter Slope (%)	N/A
N/A	Gutter Lip Ht (in)	N/A	N/A	Gutter X Slope (%)	N/A
N/A	Painted X Walk1?	No	N/A	Painted X Walk2?	N/A
	X Walk 1 Direction	To NE		X Walk 2 Direction	N/A
N/A	X Walk 1 Width (in)	N/A	N/A	X Walk 2 Width (in)	N/A
	X Walk 1 Slope (%)	3.8		X Walk 2 Slope (%)	N/A
	X Walk 1 X Slope (%)	1.4		X Walk 2 X Slope (%)	N/A

N/A	Ramp inside XWalk1?	N/A	N/A	Ramp inside XWalk2?	N/A
	Road Slope (%)	N/A	N/A	Clear Space?	N/A
	Road X Slope (%)	N/A	N/A	Clear Space to XWalk (in)	N/A
N/A	Any Obstructions?	N/A	N/A	Storm Grate/Utility Hazard?	N/A
	Obstruction Type			Storm Grate/Utility Type	
		N/A			N/A
			Yes	Surface Condition? (G/P)	Good

Possible Solutions:

**Remove & Replace Entire Ramp.**

**R304.5.1, R304.5.3**
