# Access Compliance Report

## Public Rights-of-Way

### (Curb Ramps)

Intersection ID: 10225	Main Street: E_34TH_ST	Cross Street: YADKIN_AV	Location: E
ADA ID: 249CA4E4279C	Ramp Type: Perp	Initial Pass/Fail: Fail	Overall Compliance: No
Severity Score: 10			
Codes/Mitigation Info/Possible Solution		Field Measurements/Component Compliance

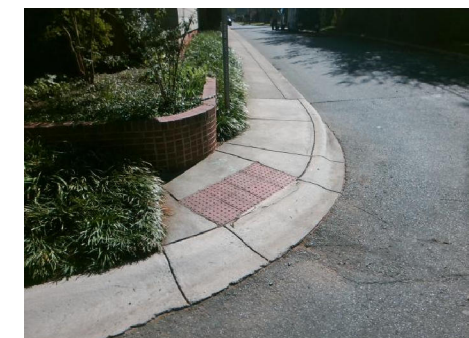
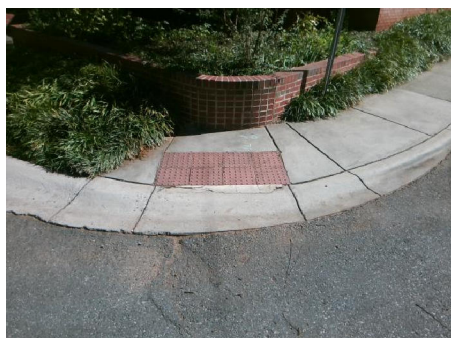
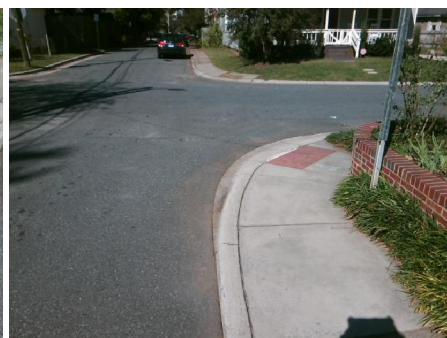
Compliance	Description	Data	Compliance	Description	Data
N/A	Ramp Length (in)	45.0	Yes	Ramp Slope (%)	7.1
No	Ramp Width (in)	41.0	No	Ramp XSlope (%)	3.0
N/A	Flare Type LT	N/A	N/A	Flare Type RT	N/A
N/A	Flare Slope LT (%)	N/A	N/A	Flare Slope RT (%)	N/A
N/A	Flare Traversable LT?	N/A	N/A	Flare Traversable RT?	N/A
N/A	Landing Length (in)	N/A	N/A	DWS Provided?	N/A
N/A	Landing Width (in)	N/A	N/A	DWS Contrast?	N/A
N/A	Landing Slope (%)	N/A	N/A	DWS Length (in)	N/A
N/A	Landing X Slope (%)	N/A	N/A	DWS Full Width?	N/A
N/A	Landing Curb? (Y/N)	N/A	N/A	DWS Offset (in)	N/A
N/A	Shared Landing?	N/A			
N/A	Gutter Ponding?	N/A	N/A	Gutter Slope (%)	N/A
N/A	Gutter Lip Ht (in)	1.0	N/A	Gutter X Slope (%)	N/A
N/A	Painted X Walk1?	No	N/A	Painted X Walk2?	N/A
	X Walk 1 Direction	To NW		X Walk 2 Direction	N/A
N/A	X Walk 1 Width (in)	N/A	N/A	X Walk 2 Width (in)	N/A
	X Walk 1 Slope (%)	3.1		X Walk 2 Slope (%)	N/A
	X Walk 1 X Slope (%)	1.1		X Walk 2 X Slope (%)	N/A

N/A	Ramp inside XWalk1?	N/A	N/A	Ramp inside XWalk2?	N/A
	Road Slope (%)	N/A	N/A	Clear Space?	N/A
	Road X Slope (%)	N/A	N/A	Clear Space to XWalk (in)	N/A
N/A	Any Obstructions?	N/A	N/A	Storm Grate/Utility Hazard?	N/A
	Obstruction Type			Storm Grate/Utility Type	
		N/A			N/A
			Yes	Surface Condition? (G/P)	Good

**Remove & Replace Entire Ramp.**
