# Access Compliance Report

## Public Rights-of-Way

### (Curb Ramps)

Intersection ID: 47361	Main Street: PARK_RD	Cross Street: N/A	Location: S
ADA ID: 249CCCD61B23	Ramp Type: Perp	Initial Pass/Fail: Pass	Overall Compliance: No
Severity Score: 17.75			
Codes/Mitigation Info/Possible Solution		Field Measurements/Component Compliance

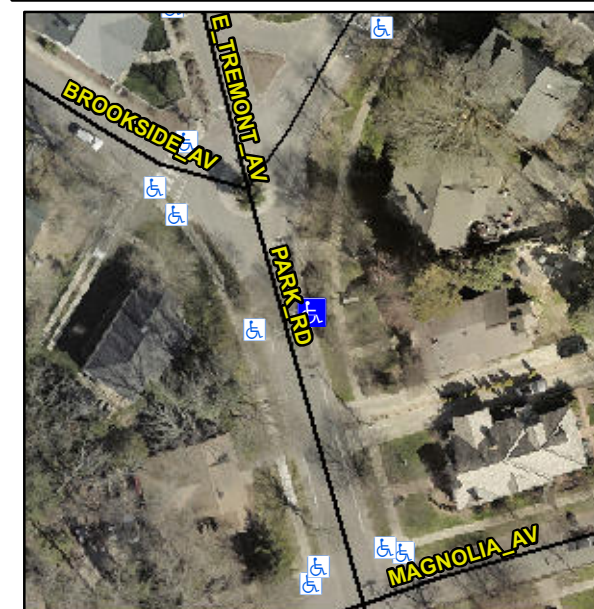
**R304.5.3, R305.1.4, R302.7.2**

Compliance	Description	Data	Compliance	Description	Data
N/A	Ramp Length (in)	141.0	Yes	Ramp Slope (%)	5.2
Yes	Ramp Width (in)	57.5	No	Ramp XSlope (%)	3.7
N/A	Flare Type LT	None	N/A	Flare Type RT	N/A
N/A	Flare Slope LT (%)	N/A	N/A	Flare Slope RT (%)	N/A
N/A	Flare Traversable LT?	N/A	N/A	Flare Traversable RT?	N/A
Yes	Landing Length (in)	59.0	Yes	DWS Provided?	Yes
Yes	Landing Width (in)	58.0	Yes	DWS Contrast?	Yes
Yes	Landing Slope (%)	1.4	Yes	DWS Length (in)	25.0
No	Landing X Slope (%)	4.9	No	DWS Full Width?	No
N/A	Landing Curb? (Y/N)	No	Yes	DWS Offset (in)	1.0
N/A	Shared Landing?	No			
Yes	Gutter Ponding?	No	Yes	Gutter Slope (%)	0.4
No	Gutter Lip Ht (in)	2.0	Yes	Gutter X Slope (%)	2.0
N/A	Painted X Walk1?	Yes	N/A	Painted X Walk2?	N/A
	X Walk 1 Direction	To W		X Walk 2 Direction	N/A
N/A	X Walk 1 Width (in)	110.0	N/A	X Walk 2 Width (in)	N/A
	X Walk 1 Slope (%)	1.2		X Walk 2 Slope (%)	N/A
	X Walk 1 X Slope (%)	1.9		X Walk 2 X Slope (%)	N/A

Yes	Ramp inside XWalk1?	Yes	N/A	Ramp inside XWalk2?	N/A
	Road Slope (%)	N/A	N/A	Clear Space?	Yes
	Road X Slope (%)	N/A	N/A	Clear Space to XWalk (in)	N/A
Yes	Any Obstructions?	No	Yes	Storm Grate/Utility Hazard?	No
	Obstruction Type			Storm Grate/Utility Type	
		N/A			N/A
			Yes	Surface Condition? (G/P)	Good

**Remove & Replace Entire Ramp.  
Grind Gutter Lip.**
