Access Compliance Report

Public Rights-of-Way

(Curb Ramps)

Intersection ID: 10022624	Main Street: CARMEL_RD	Cross Street: N/A	Location: W
ADA ID: 249F85D96380	Ramp Type: PerpDiag	Initial Pass/Fail: Fail	Overall Compliance: No
Severity Score: 21.25			
Codes/Mitigation Info/Possible Solution		Field Measurements/Component Compliance

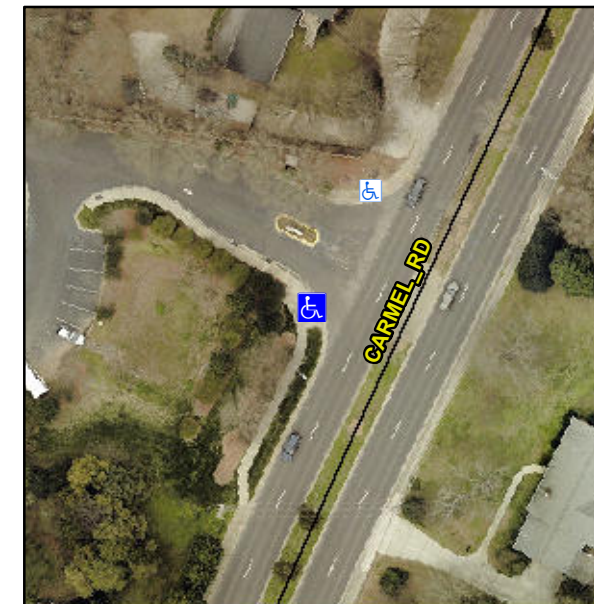
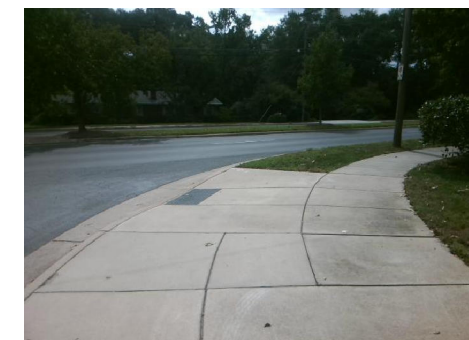
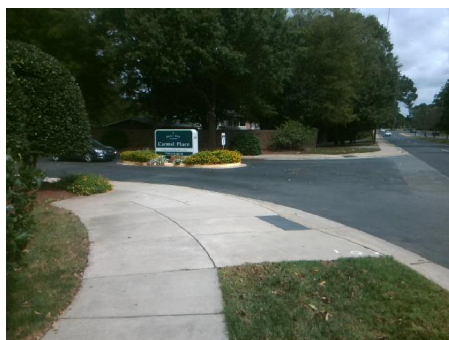
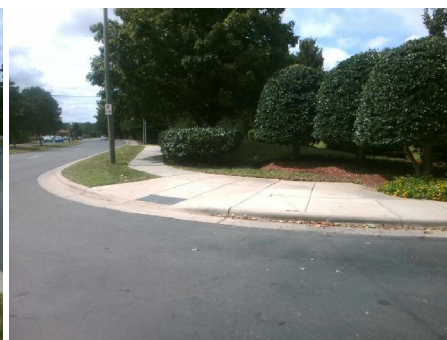
Not Found, R304.5.1, R304.2.2

Compliance	Description	Data	Compliance	Description	Data
N/A	Ramp Length (in)	97.0	No	Ramp Slope (%)	9.1
No	Ramp Width (in)	44.5	Yes	Ramp XSlope (%)	0.7
N/A	Flare Type LT	N/A	N/A	Flare Type RT	N/A
N/A	Flare Slope LT (%)	N/A	N/A	Flare Slope RT (%)	N/A
N/A	Flare Traversable LT?	N/A	N/A	Flare Traversable RT?	N/A
N/A	Landing Length (in)	N/A	N/A	DWS Provided?	N/A
N/A	Landing Width (in)	N/A	N/A	DWS Contrast?	N/A
N/A	Landing Slope (%)	N/A	N/A	DWS Length (in)	N/A
N/A	Landing X Slope (%)	N/A	N/A	DWS Full Width?	N/A
N/A	Landing Curb? (Y/N)	N/A	N/A	DWS Offset (in)	N/A
N/A	Shared Landing?	N/A			
N/A	Gutter Ponding?	N/A	N/A	Gutter Slope (%)	N/A
N/A	Gutter Lip Ht (in)	N/A	N/A	Gutter X Slope (%)	N/A
N/A	Painted X Walk1?	No	N/A	Painted X Walk2?	No
	X Walk 1 Direction	To SE		X Walk 2 Direction	To NE
N/A	X Walk 1 Width (in)	N/A	N/A	X Walk 2 Width (in)	N/A
	X Walk 1 Slope (%)	2.5		X Walk 2 Slope (%)	1.5
	X Walk 1 X Slope (%)	0.6		X Walk 2 X Slope (%)	1.2

N/A	Ramp inside XWalk1?	N/A	N/A	Ramp inside XWalk2?	N/A
	Road Slope (%)	0.4	N/A	Clear Space?	N/A
	Road X Slope (%)	1.5	N/A	Clear Space to XWalk (in)	N/A
N/A	Any Obstructions?	N/A	N/A	Storm Grate/Utility Hazard?	N/A
	Obstruction Type			Storm Grate/Utility Type	
		N/A			N/A
			Yes	Surface Condition? (G/P)	Good

Remove & Replace Curb Ramp With Two New Directional Ramps or Equivalent.
