Access Compliance Report

Public Rights-of-Way

(Curb Ramps)

Intersection ID: 43641	Main Street: HUNTINGTON_MEADOW_LN	Cross Street: KENDRICK_CROSS_RD	Location: SE
ADA ID: 24A4BE2A1A9E	Ramp Type: BlendTrans1	Initial Pass/Fail: Fail	Overall Compliance: No
Severity Score: 17.5			
Codes/Mitigation Info/Possible Solution		Field Measurements/Component Compliance

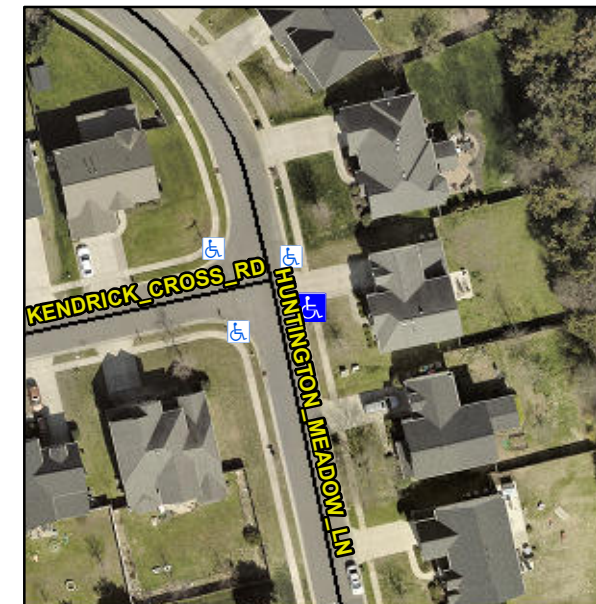
RAMP WITHIN RESIDENTIAL DRIVEWAY

Not Found, R304.5.1

Compliance	Description	Data	Compliance	Description	Data
N/A	Ramp Length (in)	50.0	Yes	BlendTrans Slope (%)	4.1
No	Ramp Width (in)	32.0	Yes	BlendTrans XSlope (%)	1.3
N/A	Flare Type LT	N/A	N/A	Flare Type RT	N/A
N/A	Flare Slope LT (%)	N/A	N/A	Flare Slope RT (%)	N/A
N/A	Flare Traversable LT?	N/A	N/A	Flare Traversable RT?	N/A
N/A	Landing Length (in)	N/A	N/A	DWS Provided?	N/A
N/A	Landing Width (in)	N/A	N/A	DWS Contrast?	N/A
N/A	Landing Slope (%)	N/A	N/A	DWS Length (in)	N/A
N/A	Landing X Slope (%)	N/A	N/A	DWS Full Width?	N/A
N/A	Landing Curb? (Y/N)	N/A	N/A	DWS Offset (in)	N/A
N/A	Shared Landing?	N/A			
N/A	Gutter Ponding?	N/A	N/A	Gutter Slope (%)	N/A
N/A	Gutter Lip Ht (in)	N/A	N/A	Gutter X Slope (%)	N/A
N/A	Painted X Walk1?	No	N/A	Painted X Walk2?	N/A
	X Walk 1 Direction	To W		X Walk 2 Direction	N/A
	X Walk 1 Width (in)	N/A		X Walk 2 Width (in)	N/A
	X Walk 1 Slope (%)	0.7		X Walk 2 Slope (%)	N/A
	X Walk 1 X Slope (%)	0.5		X Walk 2 X Slope (%)	N/A

N/A	Ramp inside XWalk1?	N/A	N/A	Ramp inside XWalk2?	N/A
	Road Slope (%)	0.5		Clear Space?	N/A
	Road X Slope (%)	0.7	N/A	Clear Space to XWalk (in)	N/A
N/A	Any Obstructions?	N/A	N/A	Storm Grate/Utility Hazard?	N/A
	Obstruction Type			Storm Grate/Utility Type	
		N/A			N/A
			Yes	Surface Condition? (G/P)	Good
			No	Curb Slope (%)	9.9

Possible Solutions:

Remove & Replace Curb Ramp With Two New Directional Ramps or Equivalent.

Total Cost: \$ 3200.00
