# Access Compliance Report

## Public Rights-of-Way

### (Curb Ramps)

Intersection ID: 27687	Main Street: BALLANTYNE_COUNTRY_CLUB_DR	Cross Street: LEE MANOR_LN	Location: NW
ADA ID: 24A67628E6AF	Ramp Type: Perp	Initial Pass/Fail: Fail	Overall Compliance: No
			Severity Score: 13.75

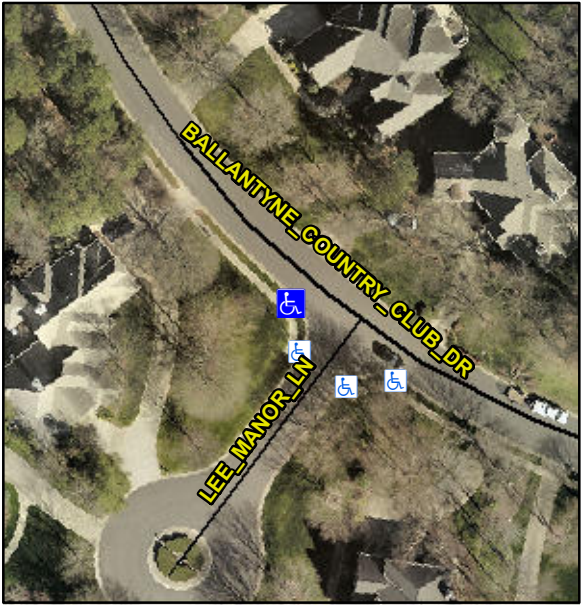
Possible Solutions:				
	Remove & Replace Entire Ramp.				
	Surveyor Notes:				
	N/A				
	PROW/ADA:				
	Not Found, R304.2.2				
		Compliance	Description	Data	Compliance
		N/A	Ramp Length (in)	47.0	No
		Yes	Ramp Width (in)	49.0	Yes
		N/A	Flare Type LT	N/A	N/A
		N/A	Flare Slope LT (%)	N/A	N/A
		N/A	Flare Traversable LT?	N/A	N/A
		N/A	Landing Length (in)	N/A	N/A
		N/A	Landing Width (in)	N/A	N/A
		N/A	Landing Slope (%)	N/A	N/A
		N/A	Landing X Slope (%)	N/A	N/A
		N/A	Landing Curb? (Y/N)	N/A	N/A
		N/A	Shared Landing?	N/A	
		N/A	Gutter Ponding?	N/A	N/A
		N/A	Gutter Lip Ht (in)	N/A	N/A
		N/A	Painted X Walk1?	No	N/A
			X Walk 1 Direction	To NE	
		N/A	X Walk 1 Width (in)	N/A	N/A
			X Walk 1 Slope (%)	3.3	
			X Walk 1 X Slope (%)	3.7	
		N/A	Ramp inside XWalk1?	N/A	N/A
			Road Slope (%)	N/A	N/A
			Road X Slope (%)	N/A	N/A
		N/A	Any Obstructions?	N/A	N/A

Obstruction Type		
				N/A	N/A
				Yes	Surface Condition? (G/P)
					Good
