# Access Compliance Report

## Public Rights-of-Way

### (Curb Ramps)

Intersection ID: 13448	Main Street: MERRIMAN_AV	Cross Street: WEST_BV	Location: NW
ADA ID: 24A8CD353633	Ramp Type: PerpDiag	Initial Pass/Fail: Fail	Overall Compliance: No
		Severity Score: 72.5

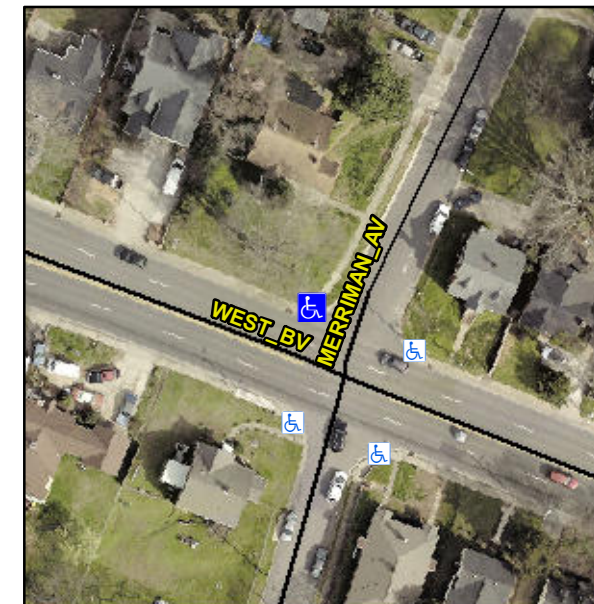
**Not Found, R304.5.1, R304.2.2, R304.5.3**

Compliance	Description	Data	Compliance	Description	Data
N/A	Ramp Length (in)	119.0	No	Ramp Slope (%)	8.4
No	Ramp Width (in)	26.0	No	Ramp XSlope (%)	8.6
N/A	Flare Type LT	N/A	N/A	Flare Type RT	N/A
N/A	Flare Slope LT (%)	N/A	N/A	Flare Slope RT (%)	N/A
N/A	Flare Traversable LT?	N/A	N/A	Flare Traversable RT?	N/A
N/A	Landing Length (in)	N/A	N/A	DWS Provided?	N/A
N/A	Landing Width (in)	N/A	N/A	DWS Contrast?	N/A
N/A	Landing Slope (%)	N/A	N/A	DWS Length (in)	N/A
N/A	Landing X Slope (%)	N/A	N/A	DWS Full Width?	N/A
N/A	Landing Curb? (Y/N)	N/A	N/A	DWS Offset (in)	N/A
N/A	Shared Landing?	N/A			
N/A	Gutter Ponding?	N/A	N/A	Gutter Slope (%)	N/A
N/A	Gutter Lip Ht (in)	N/A	N/A	Gutter X Slope (%)	N/A
N/A	Painted X Walk1?	No	N/A	Painted X Walk2?	No
	X Walk 1 Direction	To SW		X Walk 2 Direction	To SE
N/A	X Walk 1 Width (in)	N/A	N/A	X Walk 2 Width (in)	N/A
	X Walk 1 Slope (%)	8.3		X Walk 2 Slope (%)	6.7
	X Walk 1 X Slope (%)	7.9		X Walk 2 X Slope (%)	2.5

N/A	Ramp inside XWalk1?	N/A	N/A	Ramp inside XWalk2?	N/A
	Road Slope (%)	6.9	N/A	Clear Space?	N/A
	Road X Slope (%)	4.8	N/A	Clear Space to XWalk (in)	N/A
N/A	Any Obstructions?	N/A	N/A	Storm Grate/Utility Hazard?	N/A
	Obstruction Type			Storm Grate/Utility Type	
		N/A			N/A
			Yes	Surface Condition? (G/P)	Good

**Remove & Replace Curb Ramp With Two New Directional Ramps or Equivalent.**
