Access Compliance Report

Public Rights-of-Way

(Curb Ramps)

Intersection ID: 17435	Main Street: E_INDEPENDENCE_BV	Cross Street: BUICK_DR	Location: SW
ADA ID: 24B11EE25830	Ramp Type: Perp	Initial Pass/Fail: Fail	Overall Compliance: No
Severity Score: 12.5			
Codes/Mitigation Info/Possible Solution		Field Measurements/Component Compliance

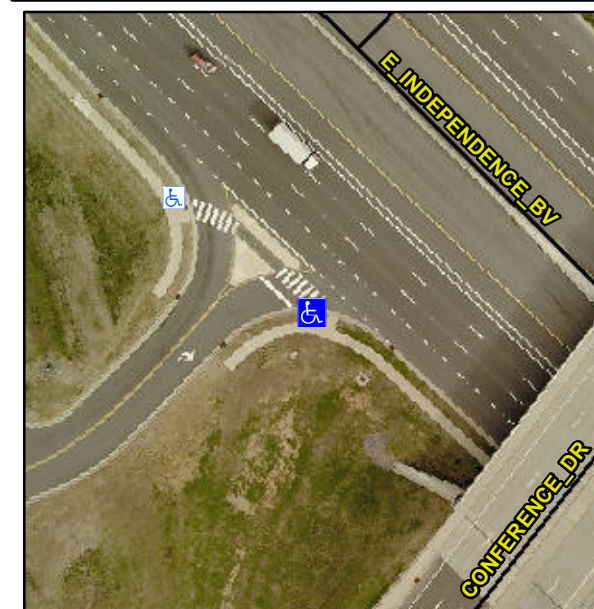
Not Found, R304.2.2

Compliance	Description	Data	Compliance	Description	Data
N/A	Ramp Length (in)	72.0	No	Ramp Slope (%)	10.2
Yes	Ramp Width (in)	59.0	Yes	Ramp XSlope (%)	1.3
N/A	Flare Type LT	N/A	N/A	Flare Type RT	N/A
N/A	Flare Slope LT (%)	N/A	N/A	Flare Slope RT (%)	N/A
N/A	Flare Traversable LT?	N/A	N/A	Flare Traversable RT?	N/A
N/A	Landing Length (in)	N/A	N/A	DWS Provided?	N/A
N/A	Landing Width (in)	N/A	N/A	DWS Contrast?	N/A
N/A	Landing Slope (%)	N/A	N/A	DWS Length (in)	N/A
N/A	Landing X Slope (%)	N/A	N/A	DWS Full Width?	N/A
N/A	Landing Curb? (Y/N)	N/A	N/A	DWS Offset (in)	N/A
N/A	Shared Landing?	N/A			
N/A	Gutter Ponding?	N/A	N/A	Gutter Slope (%)	N/A
N/A	Gutter Lip Ht (in)	N/A	N/A	Gutter X Slope (%)	N/A
N/A	Painted X Walk1?	Yes	N/A	Painted X Walk2?	N/A
	X Walk 1 Direction	To NW		X Walk 2 Direction	N/A
N/A	X Walk 1 Width (in)	120.0	N/A	X Walk 2 Width (in)	N/A
	X Walk 1 Slope (%)	1.4		X Walk 2 Slope (%)	N/A
	X Walk 1 X Slope (%)	1.1		X Walk 2 X Slope (%)	N/A

N/A	Ramp inside XWalk1?	Yes	N/A	Ramp inside XWalk2?	N/A
	Road Slope (%)	N/A	N/A	Clear Space?	N/A
	Road X Slope (%)	N/A	N/A	Clear Space to XWalk (in)	N/A
N/A	Any Obstructions?	N/A	N/A	Storm Grate/Utility Hazard?	N/A
	Obstruction Type			Storm Grate/Utility Type	
		N/A			N/A
		Yes		Surface Condition? (G/P)	Good

Possible Solutions:

Remove & Replace Entire Ramp.

Total Cost: \$ 1850.00
