Access Compliance Report Public Rights-of-Way (Curb Ramps)

Intersection ID: 9911	Main Street: BURTON_ST			Cross Street: OAKLAWN_AV				Location:	NW
ADA ID: 24C7DC573173	73 Ramp Type: PerpDiag			Initial Pass/Fail: Fail Overall Compliance: No				o Severity Score:	37.5
Codes/Mitigation Info/Possible Solution				Field Measurements/Component Compliance					
		Possible Solutions:		Compliance Description			Data Compliance Description		
		Remove & Replace Curb Ram	p With	N/A	Ramp Length (in)	61.0	No	Ramp Slope (%)	12.4
		Two New Directional Ramps or Equivalent.	or	Yes	Ramp Width (in)	50.0	No	Ramp XSlope (%)	6.0
				N/A	Flare Type LT	N/A	N/A	Flare Type RT	N/A
				N/A	Flare Slope LT (%)	N/A	N/A	Flare Slope RT (%)	N/A
En the second second				N/A	Flare Traversable LT?	N/A	N/A	Flare Traversable RT?	N/A
				N/A	Landing Length (in)	N/A	N/A	DWS Provided?	N/A
		Surveyor Notes:		N/A	Landing Width (in)	N/A	N/A	DWS Contrast?	N/A

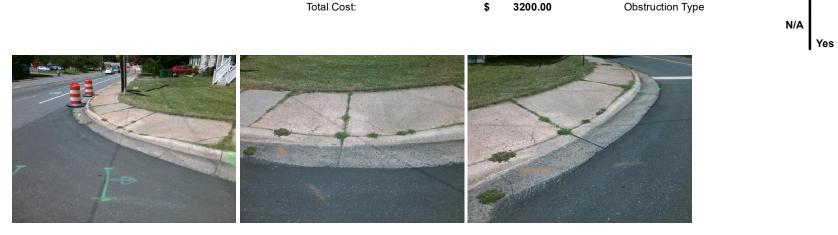
E. Le		N/A		N/A	Landing Slope (%)	N/A	N/A	DWS Length (in)	N/A
	6 Winner			N/A	Landing X Slope (%)	N/A	N/A	DWS Full Width?	N/A
K	AV			N/A	Landing Curb? (Y/N)	N/A	N/A	DWS Offset (in)	N/A
				N/A	Shared Landing?	N/A			
the second se	1	PROW/ADA:		N/A	Gutter Ponding?	N/A	N/A	Gutter Slope (%)	N/A
	. <u>6.</u>	Not Found, R304.2.2, R304.5.3	3	N/A	Gutter Lip Ht (in)	N/A	N/A	Gutter X Slope (%)	N/A
	· · ·		N/A	Painted X Walk1?	No	N/A	Painted X Walk2?	No	
	6 m			X Walk 1 Direction	To S		X Walk 2 Direction	To E	
	and the second s			N/A	X Walk 1 Width (in)	N/A	N/A	X Walk 2 Width (in)	N/A
Street 1 Name	OAKLAWN AV				X Walk 1 Slope (%)	2.1		X Walk 2 Slope (%)	5.8
Stop Condition-Street 2	None				X Walk 1 X Slope (%)	5.1		X Walk 2 X Slope (%)	0.5
Street 2 Name	DOUBLE OAKS RD			N/A	Ramp inside XWalk1?	N/A	N/A	Ramp inside XWalk2?	N/A
Stop Condition-Street 1	StopSign				Road Slope (%)	5.4	N/A	Clear Space?	N/A
					Road X Slope (%)	7.8	N/A	Clear Space to XWalk (in)	N/A

N/A	Any Obstructions?	N/A	N/A	Storm Grate/Utility Hazard?	N/A
		Total Cost: \$	3200.00		Obstruction Type			Storm Grate/Utility Type	
1						N/A			N/A
