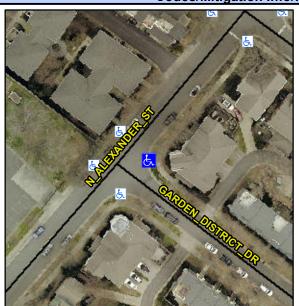
PROW/ADA:

Total Cost: \$ 3200.00

Field Measurements/Component Compliance						
	Compliance Description		Data	Compliance Description		Data
	N/A	Ramp Length (in)	71.0	Yes	Ramp Slope (%)	5.4
	No	Ramp Width (in)	45.0	No	Ramp XSlope (%)	5.0
	N/A	Flare Type LT	N/A	N/A	Flare Type RT	N/A
	N/A	Flare Slope LT (%)	N/A	N/A	Flare Slope RT (%)	N/A
	N/A	Flare Traversable LT?	N/A	N/A	Flare Traversable RT?	N/A
	N/A	Landing Length (in)	N/A	N/A	DWS Provided?	N/A
	N/A	Landing Width (in)	N/A	N/A	DWS Contrast?	N/A
	N/A	Landing Slope (%)	N/A	N/A	DWS Length (in)	N/A
	N/A	Landing X Slope (%)	N/A	N/A	DWS Full Width?	N/A
	N/A	Landing Curb? (Y/N)	N/A	N/A	DWS Offset (in)	N/A
	N/A	Shared Landing?	N/A			
	N/A	Gutter Ponding?	N/A	N/A	Gutter Slope (%)	N/A
	N/A	Gutter Lip Ht (in)	N/A	N/A	Gutter X Slope (%)	N/A
	N/A	Painted X Walk1?	No	N/A	Painted X Walk2?	No
		X Walk 1 Direction	To NW		X Walk 2 Direction	To SW
	N/A	X Walk 1 Width (in)	N/A	N/A	X Walk 2 Width (in)	N/A
		X Walk 1 Slope (%)	0.5		X Walk 2 Slope (%)	4.6

N ALEXANDER ST None GARDEN DISTRICT DR StopSign Possible Solutions:
