Access Compliance Report

Public Rights-of-Way

(Curb Ramps)

Intersection ID: 16670	Main Street: BEVERLY_DR	Cross Street: PROVIDENCE_RD	Location: SW
ADA ID: 24DF8EB5B220	Ramp Type: Perp	Initial Pass/Fail: Fail	Overall Compliance: No
Severity Score: 8.75			
Codes/Mitigation Info/Possible Solution		Field Measurements/Component Compliance

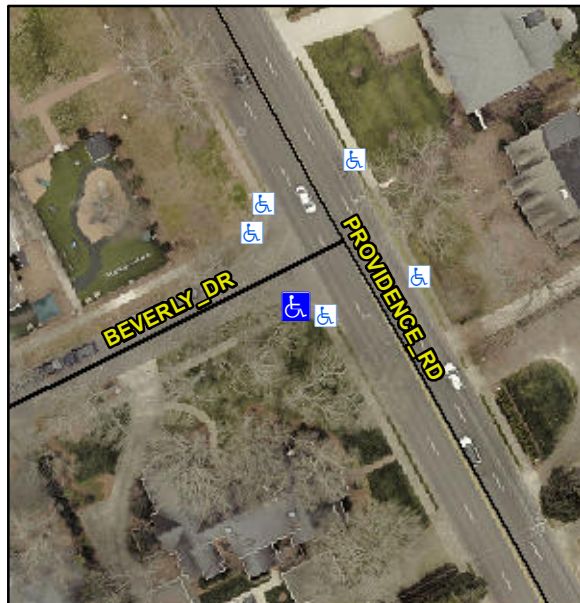
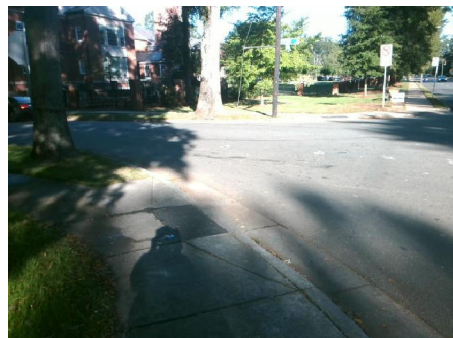
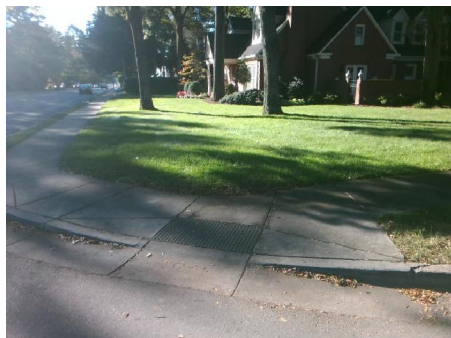
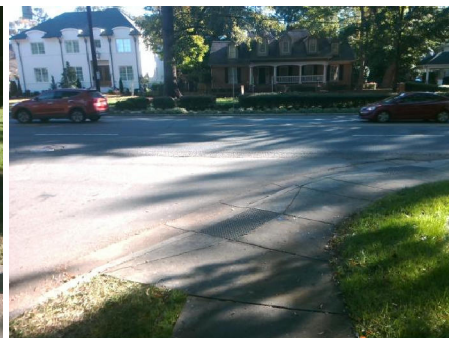
Not Found, R304.5.1

Compliance	Description	Data	Compliance	Description	Data
N/A	Ramp Length (in)	61.0	Yes	Ramp Slope (%)	6.1
No	Ramp Width (in)	45.0	Yes	Ramp XSlope (%)	1.2
N/A	Flare Type LT	N/A	N/A	Flare Type RT	N/A
N/A	Flare Slope LT (%)	N/A	N/A	Flare Slope RT (%)	N/A
N/A	Flare Traversable LT?	N/A	N/A	Flare Traversable RT?	N/A
N/A	Landing Length (in)	N/A	N/A	DWS Provided?	N/A
N/A	Landing Width (in)	N/A	N/A	DWS Contrast?	N/A
N/A	Landing Slope (%)	N/A	N/A	DWS Length (in)	N/A
N/A	Landing X Slope (%)	N/A	N/A	DWS Full Width?	N/A
N/A	Landing Curb? (Y/N)	N/A	N/A	DWS Offset (in)	N/A
N/A	Shared Landing?	N/A			
N/A	Gutter Ponding?	N/A	N/A	Gutter Slope (%)	N/A
N/A	Gutter Lip Ht (in)	N/A	N/A	Gutter X Slope (%)	N/A
N/A	Painted X Walk1?	No	N/A	Painted X Walk2?	N/A
	X Walk 1 Direction	To NW		X Walk 2 Direction	N/A
N/A	X Walk 1 Width (in)	N/A	N/A	X Walk 2 Width (in)	N/A
	X Walk 1 Slope (%)	3.9		X Walk 2 Slope (%)	N/A
	X Walk 1 X Slope (%)	0.9		X Walk 2 X Slope (%)	N/A

N/A	Ramp inside XWalk1?	N/A	N/A	Ramp inside XWalk2?	N/A
	Road Slope (%)	N/A	N/A	Clear Space?	N/A
	Road X Slope (%)	N/A	N/A	Clear Space to XWalk (in)	N/A
N/A	Any Obstructions?	N/A	N/A	Storm Grate/Utility Hazard?	N/A
	Obstruction Type			Storm Grate/Utility Type	
		N/A			N/A
			Yes	Surface Condition? (G/P)	Good

Remove & Replace Entire Ramp.

Total Cost: \$ 1850.00
