# Access Compliance Report

## Public Rights-of-Way

### (Curb Ramps)

Intersection ID: 12493	Main Street: BELVEDERE_AV	Cross Street: WINTER_ST	Location: NW
ADA ID: 24E04803E883	Ramp Type: Perp	Initial Pass/Fail: Fail	Overall Compliance: No
Severity Score: 12.5			
Codes/Mitigation Info/Possible Solution		Field Measurements/Component Compliance

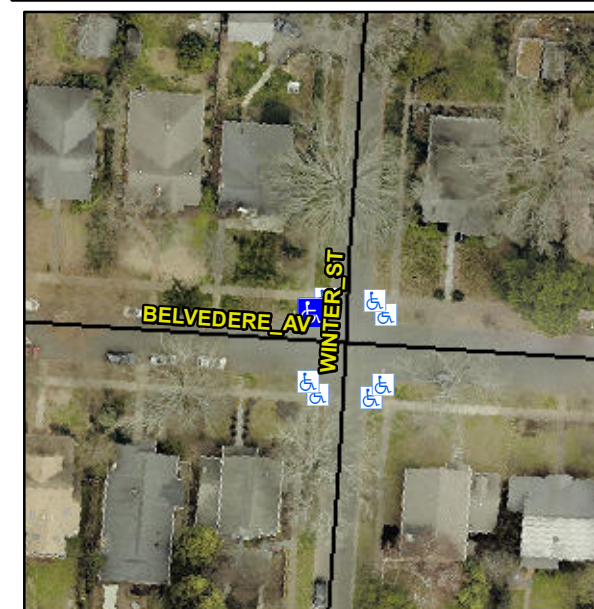
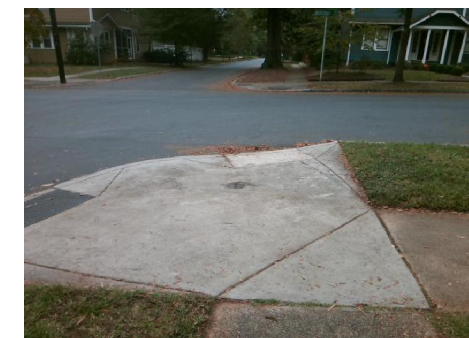
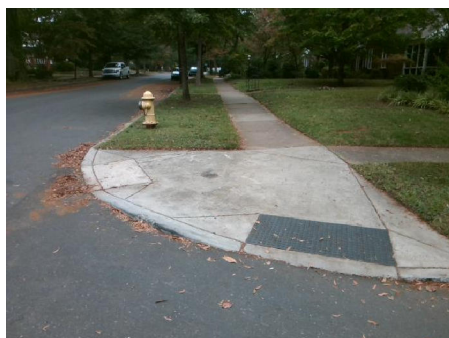
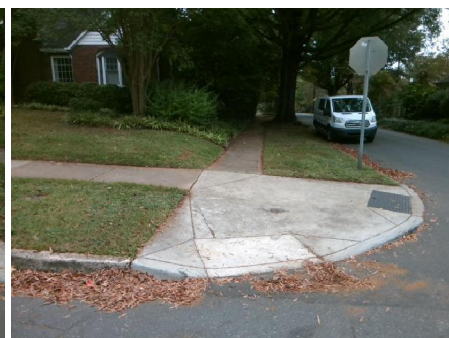
Compliance	Description	Data	Compliance	Description	Data
N/A	Ramp Length (in)	99.5	Yes	Ramp Slope (%)	6.3
Yes	Ramp Width (in)	48.0	No	Ramp XSlope (%)	5.3
N/A	Flare Type LT	N/A	N/A	Flare Type RT	N/A
N/A	Flare Slope LT (%)	N/A	N/A	Flare Slope RT (%)	N/A
N/A	Flare Traversable LT?	N/A	N/A	Flare Traversable RT?	N/A
N/A	Landing Length (in)	N/A	N/A	DWS Provided?	N/A
N/A	Landing Width (in)	N/A	N/A	DWS Contrast?	N/A
N/A	Landing Slope (%)	N/A	N/A	DWS Length (in)	N/A
N/A	Landing X Slope (%)	N/A	N/A	DWS Full Width?	N/A
N/A	Landing Curb? (Y/N)	N/A	N/A	DWS Offset (in)	N/A
N/A	Shared Landing?	N/A			
N/A	Gutter Ponding?	Yes	N/A	Gutter Slope (%)	N/A
N/A	Gutter Lip Ht (in)	N/A	N/A	Gutter X Slope (%)	N/A
N/A	Painted X Walk1?	No	N/A	Painted X Walk2?	N/A
	X Walk 1 Direction	To S		X Walk 2 Direction	N/A
N/A	X Walk 1 Width (in)	N/A	N/A	X Walk 2 Width (in)	N/A
	X Walk 1 Slope (%)	5.4		X Walk 2 Slope (%)	N/A
	X Walk 1 X Slope (%)	3.8		X Walk 2 X Slope (%)	N/A

N/A	Ramp inside XWalk1?	N/A	N/A	Ramp inside XWalk2?	N/A
	Road Slope (%)	N/A	N/A	Clear Space?	N/A
	Road X Slope (%)	N/A	N/A	Clear Space to XWalk (in)	N/A
N/A	Any Obstructions?	N/A	N/A	Storm Grate/Utility Hazard?	N/A
	Obstruction Type			Storm Grate/Utility Type	
		N/A			N/A
		Yes		Surface Condition? (G/P)	Good

**Remove & Replace Entire Ramp.**

**R304.5.3**

**\$ 1850.00**
