# Access Compliance Report

## Public Rights-of-Way

### (Curb Ramps)

Intersection ID: 9599	Main Street: CLIFTON_ST	Cross Street: OAKLAWN_AV	Location: SE
ADA ID: 24E38A0F9A1D	Ramp Type: Perp	Initial Pass/Fail: Fail	Overall Compliance: No
Severity Score: 1.25			
Codes/Mitigation Info/Possible Solution		Field Measurements/Component Compliance

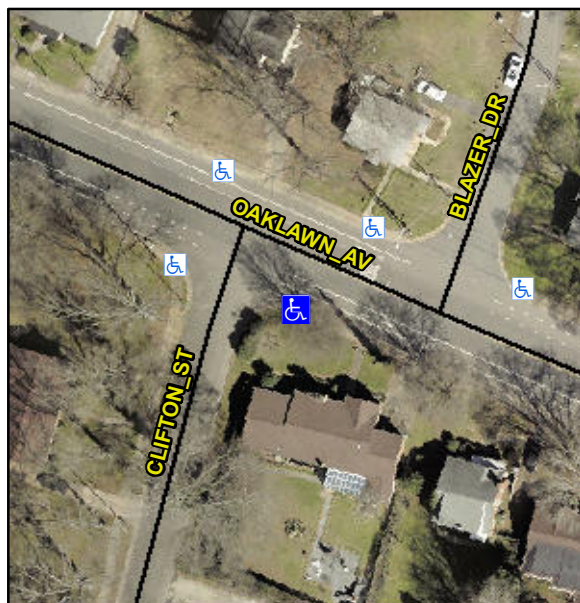
**Not Found, R304.5.3**

Compliance	Description	Data	Compliance	Description	Data
N/A	Ramp Length (in)	27.5	Yes	Ramp Slope (%)	7.2
Yes	Ramp Width (in)	94.0	No	Ramp XSlope (%)	4.7
N/A	Flare Type LT	N/A	N/A	Flare Type RT	N/A
N/A	Flare Slope LT (%)	N/A	N/A	Flare Slope RT (%)	N/A
N/A	Flare Traversable LT?	N/A	N/A	Flare Traversable RT?	N/A
N/A	Landing Length (in)	N/A	N/A	DWS Provided?	N/A
N/A	Landing Width (in)	N/A	N/A	DWS Contrast?	N/A
N/A	Landing Slope (%)	N/A	N/A	DWS Length (in)	N/A
N/A	Landing X Slope (%)	N/A	N/A	DWS Full Width?	N/A
N/A	Landing Curb? (Y/N)	N/A	N/A	DWS Offset (in)	N/A
N/A	Shared Landing?	N/A			
N/A	Gutter Ponding?	N/A	N/A	Gutter Slope (%)	N/A
N/A	Gutter Lip Ht (in)	N/A	N/A	Gutter X Slope (%)	N/A
N/A	Painted X Walk1?	No	N/A	Painted X Walk2?	N/A
	X Walk 1 Direction	To NW		X Walk 2 Direction	N/A
N/A	X Walk 1 Width (in)	N/A	N/A	X Walk 2 Width (in)	N/A
	X Walk 1 Slope (%)	3.2		X Walk 2 Slope (%)	N/A
	X Walk 1 X Slope (%)	2.6		X Walk 2 X Slope (%)	N/A

N/A	Ramp inside XWalk1?	N/A	N/A	Ramp inside XWalk2?	N/A
	Road Slope (%)	N/A	N/A	Clear Space?	N/A
	Road X Slope (%)	N/A	N/A	Clear Space to XWalk (in)	N/A
N/A	Any Obstructions?	N/A	N/A	Storm Grate/Utility Hazard?	N/A
	Obstruction Type			Storm Grate/Utility Type	
		N/A			N/A
		Yes		Surface Condition? (G/P)	Good

Possible Solutions:

**Remove & Replace Entire Ramp.**

Total Cost: \$ 1850.00
