# Access Compliance Report

## Public Rights-of-Way

### (Curb Ramps)

Intersection ID: 12684	Main Street: S_BREVARD_ST	Cross Street: E_4TH_ST	Location: W
ADA ID: 24E9BF979045	Ramp Type: Perp	Initial Pass/Fail: Fail	Overall Compliance: No
Severity Score: 22.5			
Codes/Mitigation Info/Possible Solution		Field Measurements/Component Compliance

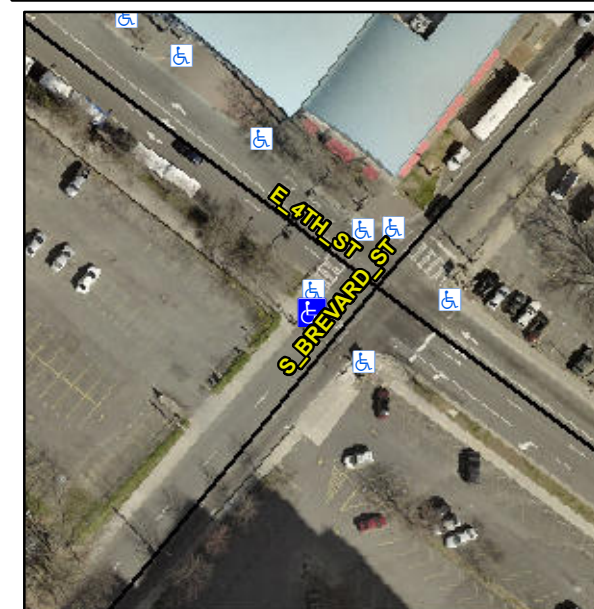
**Not Found, R304.5.1, R304.2.2**

Compliance	Description	Data	Compliance	Description	Data
N/A	Ramp Length (in)	62.0	No	Ramp Slope (%)	9.1
No	Ramp Width (in)	46.0	Yes	Ramp XSlope (%)	2.8
N/A	Flare Type LT	N/A	N/A	Flare Type RT	N/A
N/A	Flare Slope LT (%)	N/A	N/A	Flare Slope RT (%)	N/A
N/A	Flare Traversable LT?	N/A	N/A	Flare Traversable RT?	N/A
N/A	Landing Length (in)	N/A	N/A	DWS Provided?	N/A
N/A	Landing Width (in)	N/A	N/A	DWS Contrast?	N/A
N/A	Landing Slope (%)	N/A	N/A	DWS Length (in)	N/A
N/A	Landing X Slope (%)	N/A	N/A	DWS Full Width?	N/A
N/A	Landing Curb? (Y/N)	N/A	N/A	DWS Offset (in)	N/A
N/A	Shared Landing?	N/A			
N/A	Gutter Ponding?	N/A	N/A	Gutter Slope (%)	N/A
N/A	Gutter Lip Ht (in)	N/A	N/A	Gutter X Slope (%)	N/A
N/A	Painted X Walk1?	Yes	N/A	Painted X Walk2?	N/A
	X Walk 1 Direction	To SE		X Walk 2 Direction	N/A
N/A	X Walk 1 Width (in)	106.0	N/A	X Walk 2 Width (in)	N/A
	X Walk 1 Slope (%)	0.2		X Walk 2 Slope (%)	N/A
	X Walk 1 X Slope (%)	3.0		X Walk 2 X Slope (%)	N/A

N/A	Ramp inside XWalk1?	Yes	N/A	Ramp inside XWalk2?	N/A
	Road Slope (%)	N/A	N/A	Clear Space?	N/A
	Road X Slope (%)	N/A	N/A	Clear Space to XWalk (in)	N/A
N/A	Any Obstructions?	N/A	N/A	Storm Grate/Utility Hazard?	N/A
	Obstruction Type			Storm Grate/Utility Type	
		N/A			N/A
		Yes		Surface Condition? (G/P)	Good

Possible Solutions:

**Remove & Replace Entire Ramp.**

Total Cost: \$ 1850.00
