Access Compliance Report

Public Rights-of-Way

(Curb Ramps)

Intersection ID: 10041631	Main Street: WHITEHALL_PARK_DR	Cross Street: N/A	Location: NE
ADA ID: 24F35CD692D9	Ramp Type: PerpDiag	Initial Pass/Fail: Fail	Overall Compliance: No
Severity Score: 33.75			
Codes/Mitigation Info/Possible Solution		Field Measurements/Component Compliance

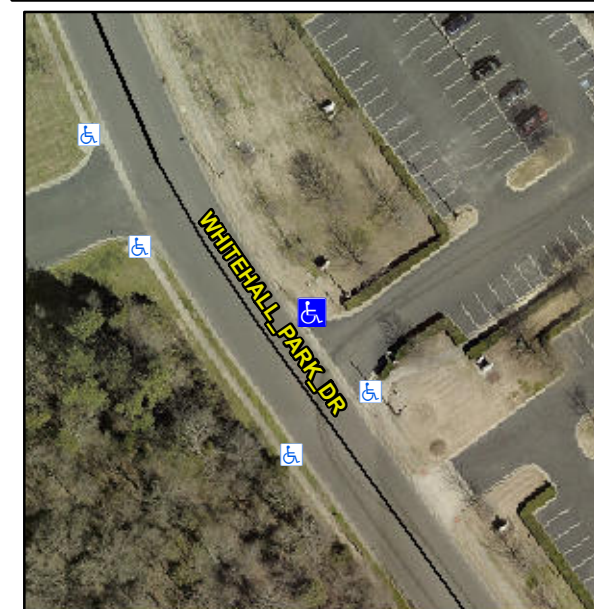
Not Found, R304.5.1, R304.2.2, R304.5.3

Compliance	Description	Data	Compliance	Description	Data
N/A	Ramp Length (in)	48.0	No	Ramp Slope (%)	9.5
No	Ramp Width (in)	42.0	No	Ramp XSlope (%)	5.7
N/A	Flare Type LT	N/A	N/A	Flare Type RT	N/A
N/A	Flare Slope LT (%)	N/A	N/A	Flare Slope RT (%)	N/A
N/A	Flare Traversable LT?	N/A	N/A	Flare Traversable RT?	N/A
N/A	Landing Length (in)	N/A	N/A	DWS Provided?	N/A
N/A	Landing Width (in)	N/A	N/A	DWS Contrast?	N/A
N/A	Landing Slope (%)	N/A	N/A	DWS Length (in)	N/A
N/A	Landing X Slope (%)	N/A	N/A	DWS Full Width?	N/A
N/A	Landing Curb? (Y/N)	N/A	N/A	DWS Offset (in)	N/A
N/A	Shared Landing?	N/A			
N/A	Gutter Ponding?	N/A	N/A	Gutter Slope (%)	N/A
N/A	Gutter Lip Ht (in)	N/A	N/A	Gutter X Slope (%)	N/A
N/A	Painted X Walk1?	No	N/A	Painted X Walk2?	No
	X Walk 1 Direction	To SW		X Walk 2 Direction	To SE
N/A	X Walk 1 Width (in)	N/A	N/A	X Walk 2 Width (in)	N/A
	X Walk 1 Slope (%)	8.3		X Walk 2 Slope (%)	0.7
	X Walk 1 X Slope (%)	1.0		X Walk 2 X Slope (%)	9.0

N/A	Ramp inside XWalk1?	N/A	N/A	Ramp inside XWalk2?	N/A
	Road Slope (%)	3.9	N/A	Clear Space?	N/A
	Road X Slope (%)	1.6	N/A	Clear Space to XWalk (in)	N/A
N/A	Any Obstructions?	N/A	N/A	Storm Grate/Utility Hazard?	N/A
	Obstruction Type			Storm Grate/Utility Type	
		N/A			N/A
			Yes	Surface Condition? (G/P)	Good

Possible Solutions:

Remove & Replace Curb Ramp With Two New Directional Ramps or Equivalent.
