# Access Compliance Report

## Public Rights-of-Way

### (Curb Ramps)

| Intersection ID: 43730 | Main Street: TIFFANY_ROSE_PL | Cross Street: W_CRAIGHEAD_RD | Location: SE |

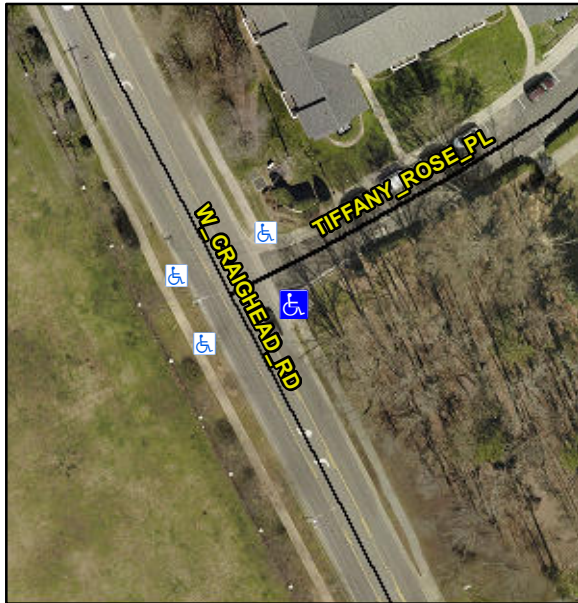
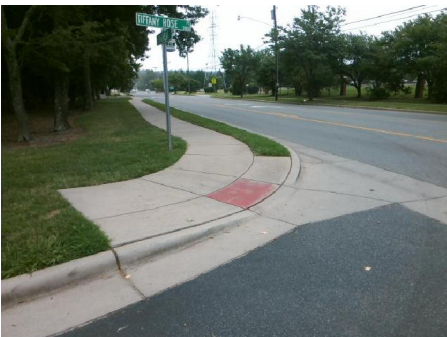
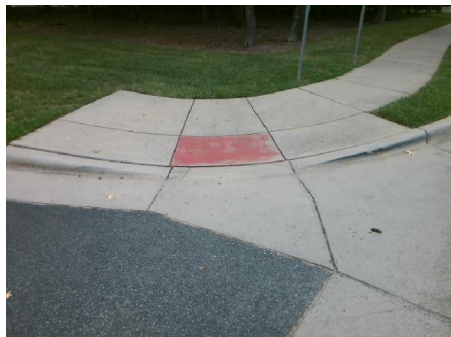
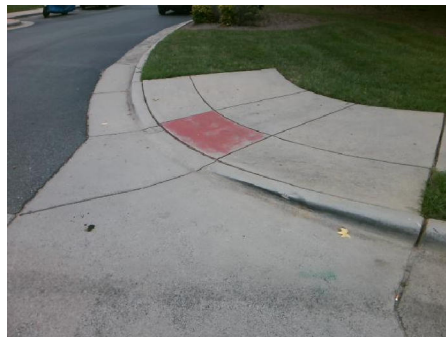
**CURB LIP 1.0, NO LT SW**

**Not Found, R304.5.1**

| Compliance | Description | Data | Compliance | Description | Data |
|---|---|---|---|---|---|
| No | Ramp Width (in) | 43.0 | Yes | BlendTrans XSlope (%) | 0.5 |
| | | | No | Curb Slope (%) | 11.9 |

**Remove & Replace Curb Ramp With Two New Directional Ramps or Equivalent.**
