# Access Compliance Report

## Public Rights-of-Way

### (Curb Ramps)

| Intersection ID: 42838 | Main Street: SARDIS_OAKS_RD | Cross Street: SARDIS_RD_NORTH | Location: SW |

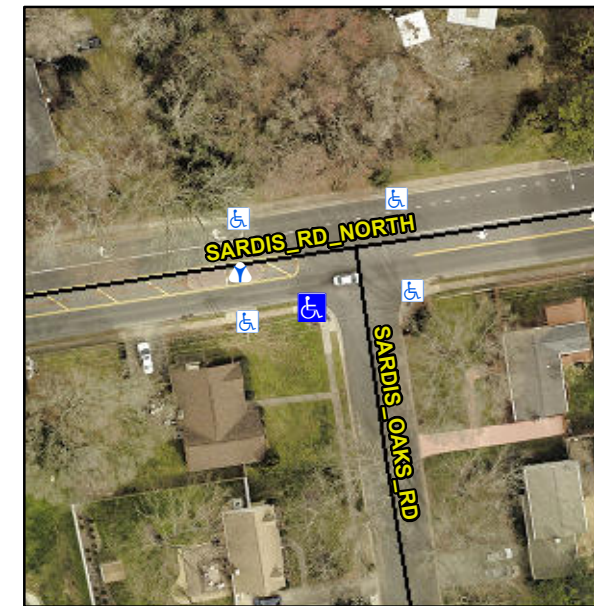
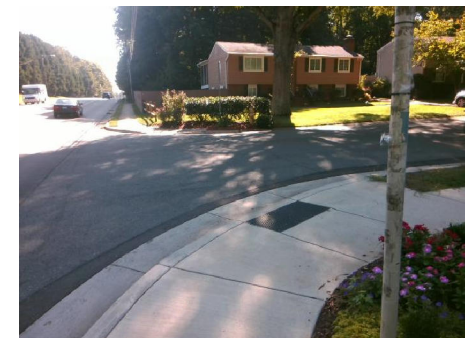
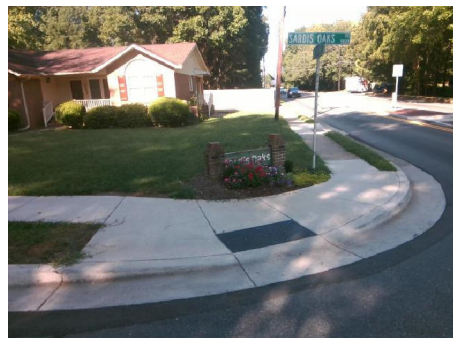
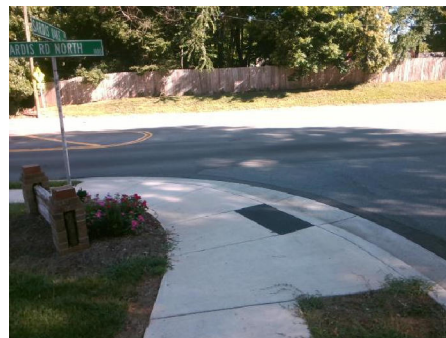
| ADA ID: 250F0D7FEB15 | Ramp Type: BlendTrans2 | Initial Pass/Fail: Fail | Overall Compliance: No |
| | | Severity Score: 21.25 | |

**Not Found, R304.5.1, R304.5.3**

| Compliance | Description | Data | Compliance | Description | Data |
|---|---|---|---|---|---|
| No | Ramp Width (in) | 41.0 | No | BlendTrans XSlope (%) | 5.4 |

**Remove & Replace Curb Ramp With Two New Directional Ramps or Equivalent.**

Total Cost: \$ 3200.00
