# Access Compliance Report

## Public Rights-of-Way

### (Curb Ramps)

| Intersection ID: 10038891 | Main Street: STIRLINGSHIRE_CT | Cross Street: N/A | Location: SW |

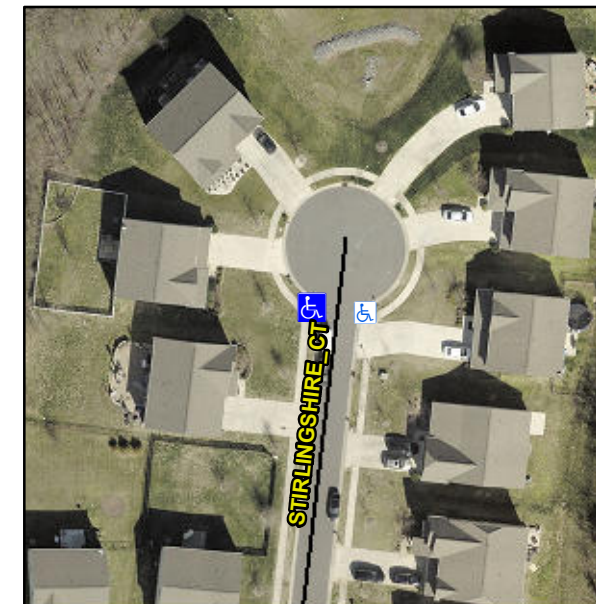
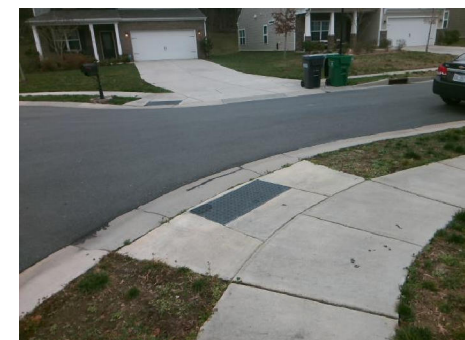
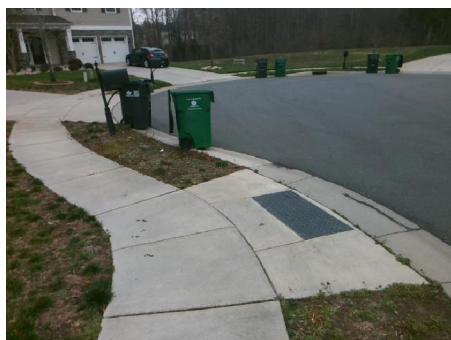
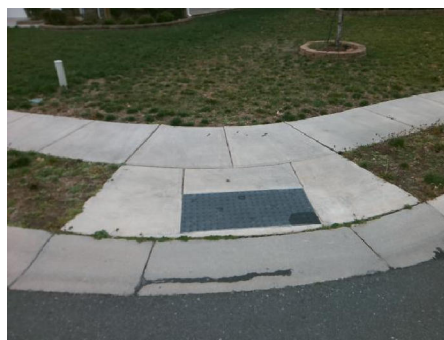
| ADA ID: 250F8600A193 | Ramp Type: BlendTrans1 | Initial Pass/Fail: Pass | Overall Compliance: No |
| Severity Score: 0.25 | | | |

| Compliance | Description | Data | Compliance | Description | Data |
|---|---|---|---|---|---|
| Yes | Ramp Width (in) | 48.0 | No | BlendTrans XSlope (%) | 2.3 |
| No | Landing Width (in) | 47.5 | Yes | DWS Contrast? | Yes |
| No | Landing Slope (%) | 5.6 | Yes | DWS Length (in) | 24.0 |
| No | Landing X Slope (%) | 3.3 | Yes | DWS Full Width? | Yes |
| N/A | Landing Curb? (Y/N) | No | No | DWS Offset (in) | 4.0 |

**Remove & Replace Curb Ramp With Two New Directional Ramps or Equivalent.**

Total Cost: \$ 3200.00
