Access Compliance Report

Public Rights-of-Way

(Curb Ramps)

Intersection ID: 8184	Main Street: ENGLISH_DR	Cross Street: SOUTHWEST_BV	Location: SE
ADA ID: 2512F2C68B04	Ramp Type: BlendTrans1	Initial Pass/Fail: Fail	Overall Compliance: No
		Severity Score: 12.5

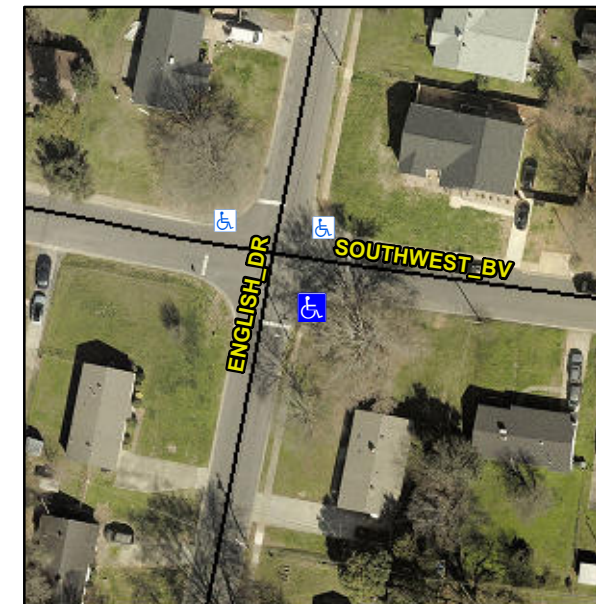
NO LT SW

Not Found, R304.5.3

Compliance	Description	Data	Compliance	Description	Data
N/A	Ramp Length (in)	70.0	Yes	BlendTrans Slope (%)	1.2
Yes	Ramp Width (in)	50.0	No	BlendTrans XSlope (%)	6.1
N/A	Flare Type LT	N/A	N/A	Flare Type RT	N/A
N/A	Flare Slope LT (%)	N/A	N/A	Flare Slope RT (%)	N/A
N/A	Flare Traversable LT?	N/A	N/A	Flare Traversable RT?	N/A
N/A	Landing Length (in)	N/A	N/A	DWS Provided?	N/A
N/A	Landing Width (in)	N/A	N/A	DWS Contrast?	N/A
N/A	Landing Slope (%)	N/A	N/A	DWS Length (in)	N/A
N/A	Landing X Slope (%)	N/A	N/A	DWS Full Width?	N/A
N/A	Landing Curb? (Y/N)	N/A	N/A	DWS Offset (in)	N/A
N/A	Shared Landing?	N/A			
N/A	Gutter Ponding?	N/A	N/A	Gutter Slope (%)	N/A
N/A	Gutter Lip Ht (in)	N/A	N/A	Gutter X Slope (%)	N/A
N/A	Painted X Walk1?	No	N/A	Painted X Walk2?	N/A
	X Walk 1 Direction	To N		X Walk 2 Direction	N/A
	X Walk 1 Width (in)	N/A		X Walk 2 Width (in)	N/A
	X Walk 1 Slope (%)	3.8		X Walk 2 Slope (%)	N/A
	X Walk 1 X Slope (%)	2.3		X Walk 2 X Slope (%)	N/A

N/A	Ramp inside XWalk1?	N/A	N/A	Ramp inside XWalk2?	N/A
	Road Slope (%)	2.3		Clear Space?	N/A
	Road X Slope (%)	3.8	N/A	Clear Space to XWalk (in)	N/A
N/A	Any Obstructions?	N/A	N/A	Storm Grate/Utility Hazard?	N/A
	Obstruction Type			Storm Grate/Utility Type	
		N/A			N/A
			Yes	Surface Condition? (G/P)	Good
			No	Curb Slope (%)	7.7

Remove & Replace Curb Ramp With Two New Directional Ramps or Equivalent.
