# Access Compliance Report

## Public Rights-of-Way

### (Curb Ramps)

Intersection ID: 14918	Main Street: KENILWORTH_AV	Cross Street: PIERCE_ST	Location:	N
ADA ID: 2515BFD65E62	Ramp Type: Directional1	Initial Pass/Fail: Fail	Overall Compliance: No	Severity Score: 1.25
Codes/Mitigation Info/Possible Solution		Field Measurements/Component Compliance

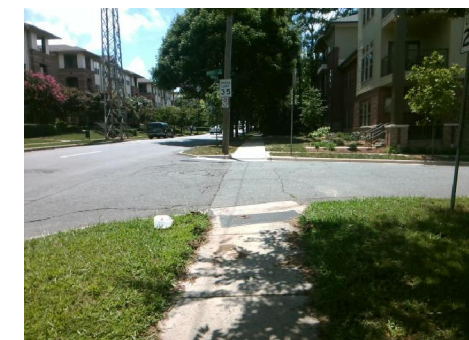
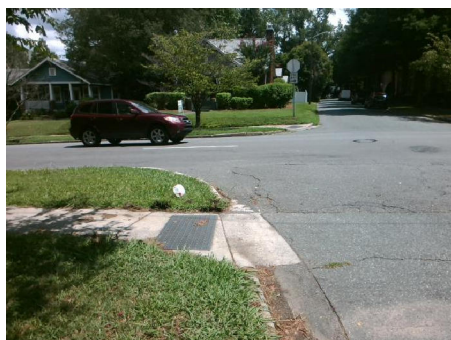
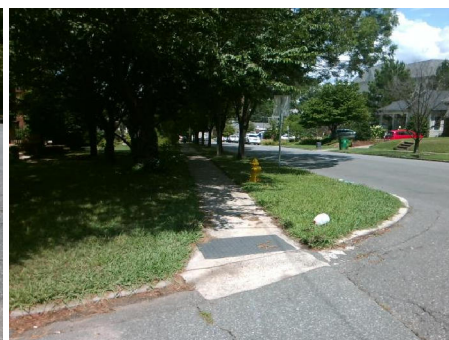
Compliance	Description	Data	Compliance	Description	Data
N/A	Ramp Length (in)	34.0	N/A	Grade Break?	N/A
Yes	Ramp Width (in)	58.0	N/A	Grade Break Slope (%)	0.0
Yes	Ramp Slope (%)	2.6	N/A	Grade Break XSlope (%)	0.0
No	Ramp XSlope (%)	4.6			
N/A	Flare Type LT	N/A	N/A	Flare Type RT	N/A
N/A	Flare Slope LT (%)	N/A	N/A	Flare Slope RT (%)	0.0
N/A	Flare Traversable LT?	N/A	N/A	Flare Traversable RT?	N/A
N/A	Landing Length (in)	0.0	N/A	DWS Provided?	N/A
N/A	Landing Width (in)	0.0	N/A	DWS Contrast?	N/A
N/A	Landing Slope (%)	0.0	N/A	DWS Length (in)	N/A
N/A	Landing X Slope (%)	0.0	N/A	DWS Full Width?	N/A
N/A	Landing Curb? (Y/N)	N/A	N/A	DWS Offset LT (in)	N/A
N/A	Shared Landing?	N/A	N/A	DWS Offset RT (in)	N/A
N/A	Gutter Ponding?	0.0	N/A	Gutter Slope (%)	N/A
N/A	Gutter Lip Ht (in)	0.0	N/A	Gutter X Slope (%)	N/A
N/A	Painted X Walk1?	No		Road Slope (%)	7.7
	X Walk 1 Direction	To SW		Road X Slope (%)	0.4
	X Walk 1 Width (in)	N/A		Clear Space?	N/A

X Walk 1 Slope (%)	7.7	N/A	Clear Space to XWalk (in)	N/A
	X Walk 1 X Slope (%)	0.4	N/A	Storm Grate/Utility Hazard?	N/A
N/A	Ramp inside XWalk1?	N/A		Storm Grate/Utility Type	
N/A	Any Obstructions?	N/A			N/A
	Obstruction Type		Yes	Surface Condition? (G/P)	Good
			N/A	Curb Slope (%)	8.8

Possible Solutions:

**Remove & Replace Entire Ramp.**

**R304.5.3**

\$ 1600.00
