Access Compliance Report

Public Rights-of-Way

(Curb Ramps)

| Intersection ID: 27813 | Main Street: DUCKSBILL_DR | Cross Street: PARKS_FARM_LN | Location: NE |

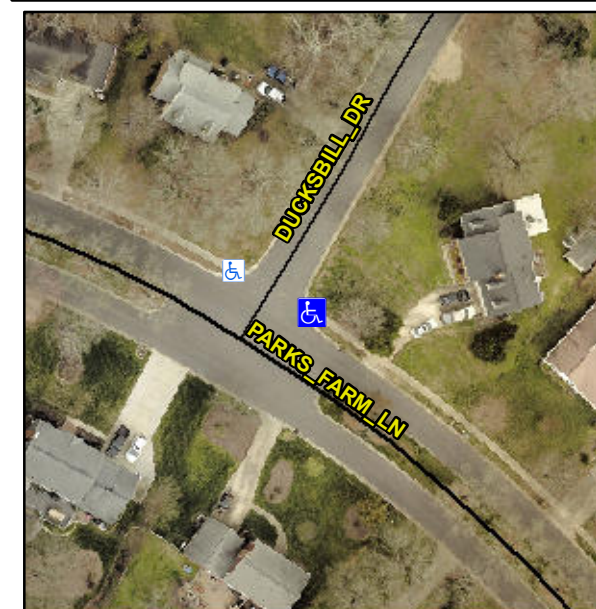
| ADA ID: 251B166DD36B | Ramp Type: Perp | Initial Pass/Fail: Fail | Overall Compliance: No |
| Severity Score: 12.5 | | | |

| Compliance | Description | Data | Compliance | Description | Data |
|---|---|---|---|---|---|
| N/A | Ramp Length (in) | 300.0 | Yes | Ramp Slope (%) | 10.4 |
| Yes | Ramp Width (in) | 48.0 | Yes | Ramp XSlope (%) | 1.6 |

Possible Solutions:

Remove & Replace Entire Ramp.
