# Access Compliance Report

## Public Rights-of-Way

### (Curb Ramps)

| Intersection ID: 53916 | Main Street: TULOCAY_LN | Cross Street: BRITTONDALE_LN | Location: E |

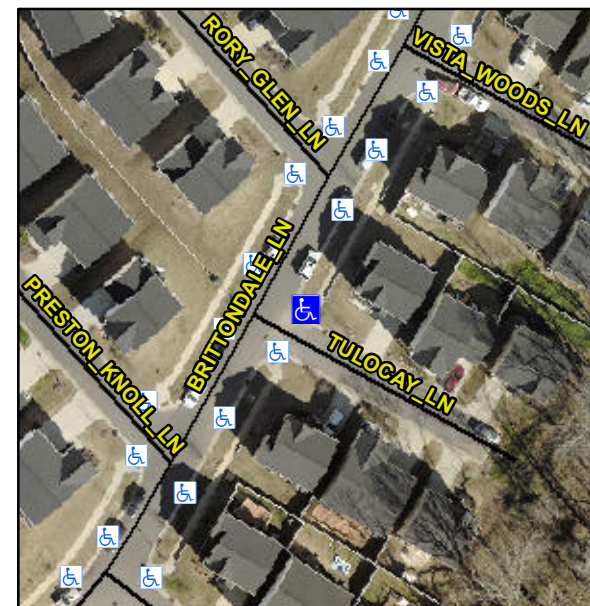
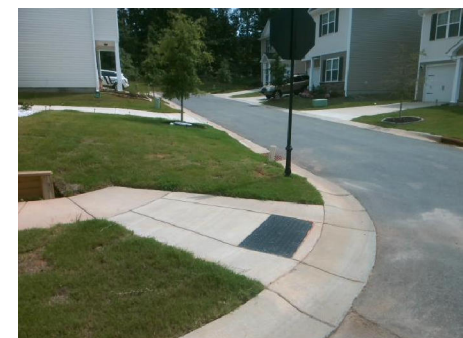
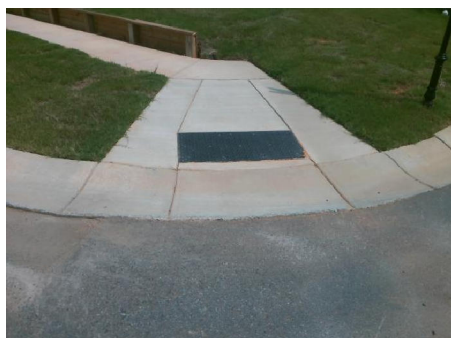
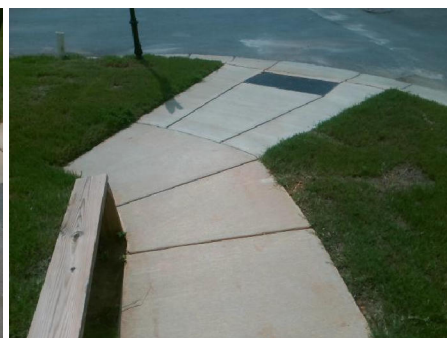
| ADA ID: 251DEEA22A4D | Ramp Type: PerpDiag | Initial Pass/Fail: Fail | Overall Compliance: No |

**Not Found, R304.5.1, R304.5.3**

| Compliance | Description | Data | Compliance | Description | Data |
|---|---|---|---|---|---|
| N/A | Ramp Length (in) | 97.0 | Yes | Ramp Slope (%) | 7.2 |
| No | Ramp Width (in) | 28.0 | No | Ramp XSlope (%) | 2.2 |

**Remove & Replace Curb Ramp With Two New Directional Ramps or Equivalent.**

Total Cost: \$ 3200.00
