# Access Compliance Report Public Rights-of-Way (Curb Ramps)

Intersection ID: 16184	Main Street: CRAIG_AV	Cross Street: MCALWAY_RD	Location: NW
ADA ID: 2521266D1876	Ramp Type: PerpDiag	Initial Pass/Fail: Fail	Overall Compliance: No Severity Score: 47.5

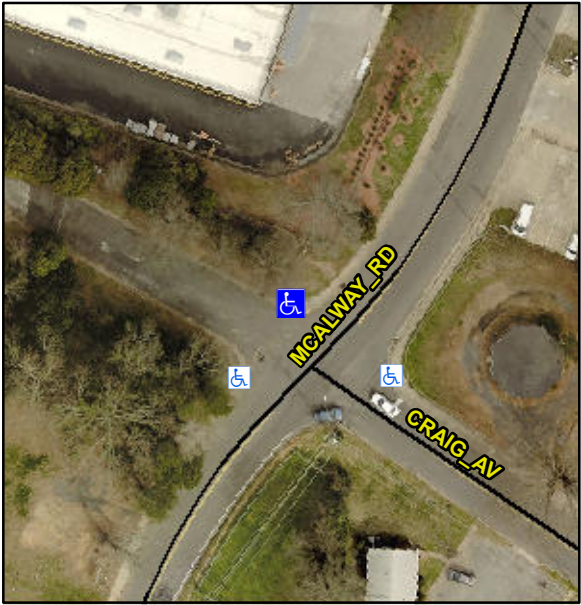
PROW/ADA:  
**Not Found, R304.5.1, R304.5.3**

Compliance	Description	Data	Compliance	Description	Data
N/A	Ramp Length (in)	51.0	Yes	Ramp Slope (%)	5.4
No	Ramp Width (in)	25.0	No	Ramp XSlope (%)	5.3
N/A	Flare Type LT	N/A	N/A	Flare Type RT	N/A
N/A	Flare Slope LT (%)	N/A	N/A	Flare Slope RT (%)	N/A
N/A	Flare Traversable LT?	N/A	N/A	Flare Traversable RT?	N/A
N/A	Landing Length (in)	N/A	N/A	DWS Provided?	N/A
N/A	Landing Width (in)	N/A	N/A	DWS Contrast?	N/A
N/A	Landing Slope (%)	N/A	N/A	DWS Length (in)	N/A
N/A	Landing X Slope (%)	N/A	N/A	DWS Full Width?	N/A
N/A	Landing Curb? (Y/N)	N/A	N/A	DWS Offset (in)	N/A
N/A	Shared Landing?	N/A			
N/A	Gutter Ponding?	N/A	N/A	Gutter Slope (%)	N/A
N/A	Gutter Lip Ht (in)	0.5	N/A	Gutter X Slope (%)	N/A
N/A	Painted X Walk1?	No	N/A	Painted X Walk2?	No
	X Walk 1 Direction	To SW		X Walk 2 Direction	To SE
N/A	X Walk 1 Width (in)	N/A	N/A	X Walk 2 Width (in)	N/A
	X Walk 1 Slope (%)	3.4		X Walk 2 Slope (%)	1.9
	X Walk 1 X Slope (%)	2.5		X Walk 2 X Slope (%)	4.3

N/A	Ramp inside XWalk1?	N/A	N/A	Ramp inside XWalk2?	N/A
	Road Slope (%)	5.0	N/A	Clear Space?	N/A
	Road X Slope (%)	0.8	N/A	Clear Space to XWalk (in)	N/A
N/A	Any Obstructions?	N/A	N/A	Storm Grate/Utility Hazard?	N/A
	Obstruction Type			Storm Grate/Utility Type	
		N/A			N/A
			Yes	Surface Condition? (G/P)	Good

Possible Solutions:  
**Remove & Replace Curb Ramp With Two New Directional Ramps or Equivalent.**
