Access Compliance Report

Public Rights-of-Way

(Curb Ramps)

Intersection ID: 9678	Main Street: THE_PLAZA	Cross Street: VANDERBROOK_RD	Location: SW
ADA ID: 25256E572CB6	Ramp Type: Perp	Initial Pass/Fail: Fail	Overall Compliance: No
Severity Score: 46.25			
Codes/Mitigation Info/Possible Solution		Field Measurements/Component Compliance

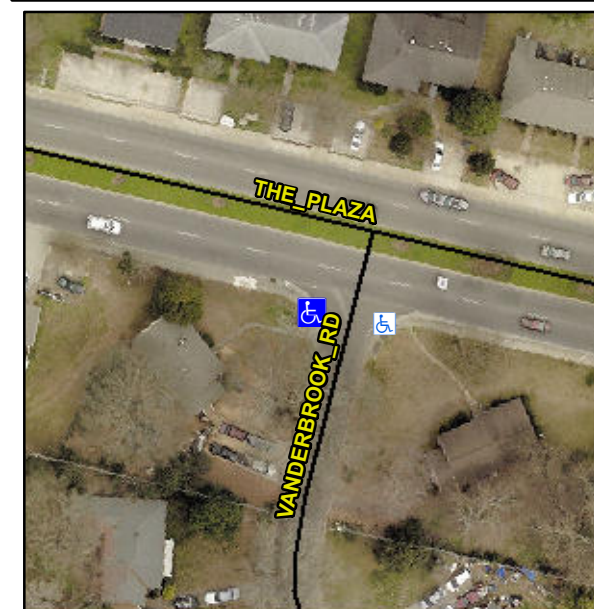
Not Found, R304.5.1, R304.2.2, R304.5.3

Compliance	Description	Data	Compliance	Description	Data
N/A	Ramp Length (in)	60.5	No	Ramp Slope (%)	8.6
No	Ramp Width (in)	47.5	No	Ramp XSlope (%)	7.0
N/A	Flare Type LT	N/A	N/A	Flare Type RT	N/A
N/A	Flare Slope LT (%)	N/A	N/A	Flare Slope RT (%)	N/A
N/A	Flare Traversable LT?	N/A	N/A	Flare Traversable RT?	N/A
N/A	Landing Length (in)	N/A	N/A	DWS Provided?	N/A
N/A	Landing Width (in)	N/A	N/A	DWS Contrast?	N/A
N/A	Landing Slope (%)	N/A	N/A	DWS Length (in)	N/A
N/A	Landing X Slope (%)	N/A	N/A	DWS Full Width?	N/A
N/A	Landing Curb? (Y/N)	N/A	N/A	DWS Offset (in)	N/A
N/A	Shared Landing?	N/A			
N/A	Gutter Ponding?	N/A	N/A	Gutter Slope (%)	N/A
N/A	Gutter Lip Ht (in)	N/A	N/A	Gutter X Slope (%)	N/A
N/A	Painted X Walk1?	No	N/A	Painted X Walk2?	N/A
	X Walk 1 Direction	To SE		X Walk 2 Direction	N/A
N/A	X Walk 1 Width (in)	N/A	N/A	X Walk 2 Width (in)	N/A
	X Walk 1 Slope (%)	2.7		X Walk 2 Slope (%)	N/A
	X Walk 1 X Slope (%)	9.8		X Walk 2 X Slope (%)	N/A

N/A	Ramp inside XWalk1?	N/A	N/A	Ramp inside XWalk2?	N/A
	Road Slope (%)	N/A	N/A	Clear Space?	N/A
	Road X Slope (%)	N/A	N/A	Clear Space to XWalk (in)	N/A
N/A	Any Obstructions?	N/A	N/A	Storm Grate/Utility Hazard?	N/A
	Obstruction Type			Storm Grate/Utility Type	
		N/A			N/A
			Yes	Surface Condition? (G/P)	Good

Possible Solutions:

Remove & Replace Entire Ramp.
