# Access Compliance Report

## Public Rights-of-Way

### (Curb Ramps)

| Intersection ID: 29798 | Main Street: RUDOLPH_DADEY_DR | Cross Street: SMART_LN | Location: W |

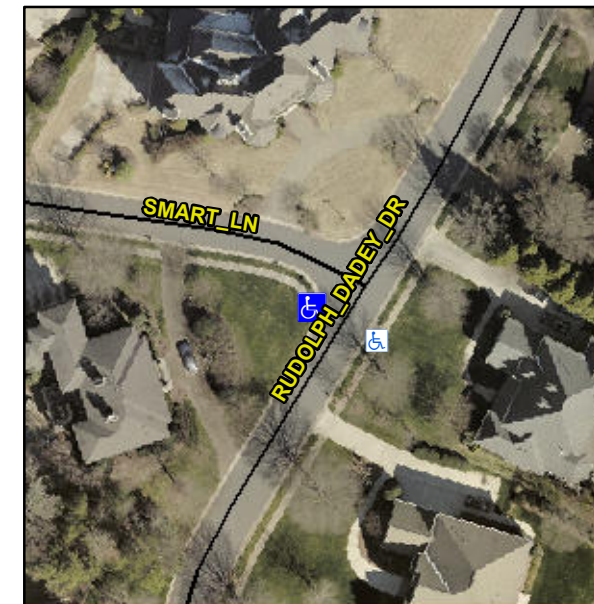
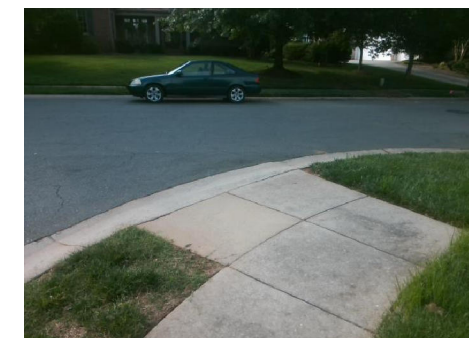
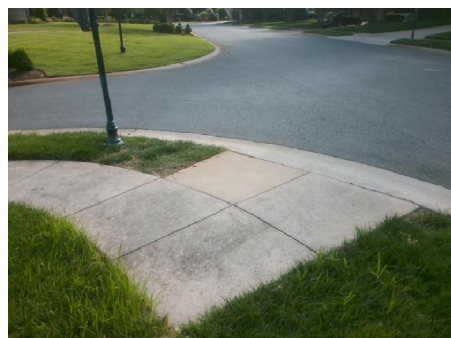
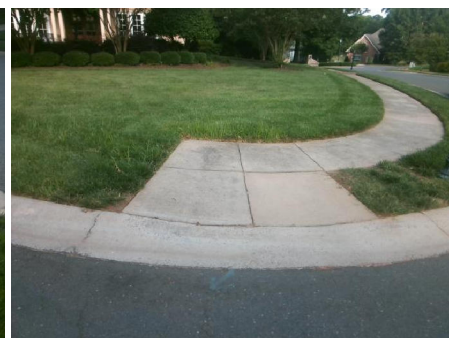
**Not Found, R304.5.3, R304.2.1, R304.2.2-Perp, R304.3.2-Para, R305**

| Compliance | Description | Data | Compliance | Description | Data |
|---|---|---|---|---|---|
| N/A | Ramp Length (in) | 48.0 | Yes | Ramp Slope (%) | 5.3 |
| Yes | Ramp Width (in) | 48.0 | No | Ramp XSlope (%) | 4.4 |
| No | Landing Length (in) | 46.0 | No | DWS Provided? | No |
| No | Landing Slope (%) | 2.5 | N/A | DWS Length (in) | N/A |
| Yes | Gutter Lip Ht (in) | 0.0 | No | Gutter X Slope (%) | 3.3 |

**Remove & Replace Curb Ramp With Two New Directional Ramps or Equivalent. Remove & Replace Gutter.**
