# Access Compliance Report

## Public Rights-of-Way

### (Curb Ramps)

Intersection ID: 52169	Main Street: AVERY_MEADOWS_DR	Cross Street: BEATTIES_FORD_RD	Location:	N
ADA ID: 252C40523B6D	Ramp Type: Perp	Initial Pass/Fail: Fail	Overall Compliance: No	Severity Score: 1.25

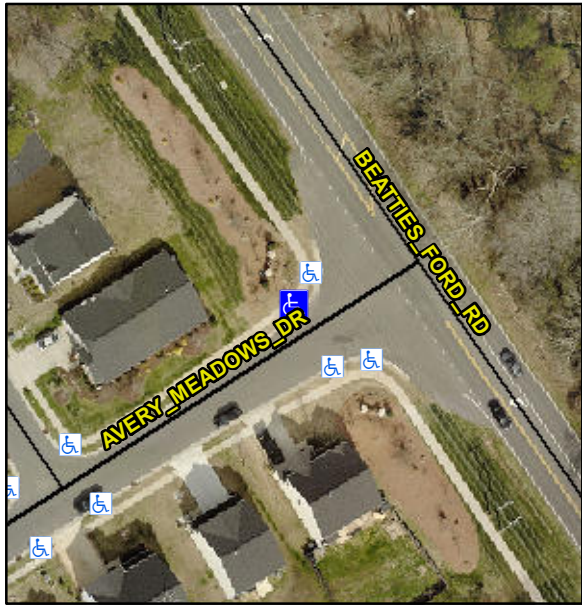
Possible Solutions:		<b>Compliance</b>			<b>Description</b>			<b>Data</b>			
	<b>Remove &amp; Replace Entire Ramp.</b>		<b>N/A</b>	Ramp Length (in)		<b>39.0</b>		<b>Yes</b>	Ramp Slope (%)		<b>5.6</b>	
			<b>Yes</b>	Ramp Width (in)		<b>48.0</b>		<b>No</b>	Ramp XSlope (%)		<b>2.9</b>	
			<b>N/A</b>	Flare Type LT		<b>N/A</b>		<b>N/A</b>	Flare Type RT		<b>N/A</b>	
			<b>N/A</b>	Flare Slope LT (%)		<b>N/A</b>		<b>N/A</b>	Flare Slope RT (%)		<b>N/A</b>	
			<b>N/A</b>	Flare Traversable LT?		<b>N/A</b>		<b>N/A</b>	Flare Traversable RT?		<b>N/A</b>	
			<b>N/A</b>	Landing Length (in)		<b>N/A</b>		<b>N/A</b>	DWS Provided?		<b>N/A</b>	
			<b>N/A</b>	Landing Width (in)		<b>N/A</b>		<b>N/A</b>	DWS Contrast?		<b>N/A</b>	
			<b>N/A</b>	Landing Slope (%)		<b>N/A</b>		<b>N/A</b>	DWS Length (in)		<b>N/A</b>	
			<b>N/A</b>	Landing X Slope (%)		<b>N/A</b>		<b>N/A</b>	DWS Full Width?		<b>N/A</b>

Surveyor Notes:		<b>N/A</b>			<b>N/A</b>			DWS Offset (in)			<b>N/A</b>	
PROW/ADA:		<b>Not Found, R304.5.3</b>			<b>N/A</b>							
					<b>N/A</b>			Gutter Ponding?			<b>N/A</b>	
					<b>N/A</b>			Gutter Lip Ht (in)			<b>N/A</b>	
					<b>N/A</b>			Painted X Walk1?			<b>No</b>	
					<b>To S</b>			X Walk 2 Direction			<b>N/A</b>	
					<b>N/A</b>			X Walk 2 Width (in)			<b>N/A</b>	
					<b>2.4</b>			X Walk 2 Slope (%)			<b>N/A</b>	
					<b>0.5</b>			X Walk 2 X Slope (%)			<b>N/A</b>	
					<b>N/A</b>			Ramp inside XWalk2?			<b>N/A</b>	
					<b>N/A</b>			Clear Space?			<b>N/A</b>	
					<b>N/A</b>			Clear Space to XWalk (in)			<b>N/A</b>	
					<b>N/A</b>			Storm Grate/Utility Hazard?			<b>N/A</b>	
								Storm Grate/Utility Type				
					<b>N/A</b>						<b>N/A</b>	
								<b>Yes</b>			Surface Condition? (G/P)	
											<b>Good</b>
