Access Compliance Report

Public Rights-of-Way

(Curb Ramps)

Intersection ID: 11943	Main Street: PEGRAM_ST	Cross Street: KENNON_ST	Location: SE
ADA ID: 2530DCCA3C8F	Ramp Type: Para	Initial Pass/Fail: Fail	Overall Compliance: No
Severity Score: 13.75			
Codes/Mitigation Info/Possible Solution		Field Measurements/Component Compliance

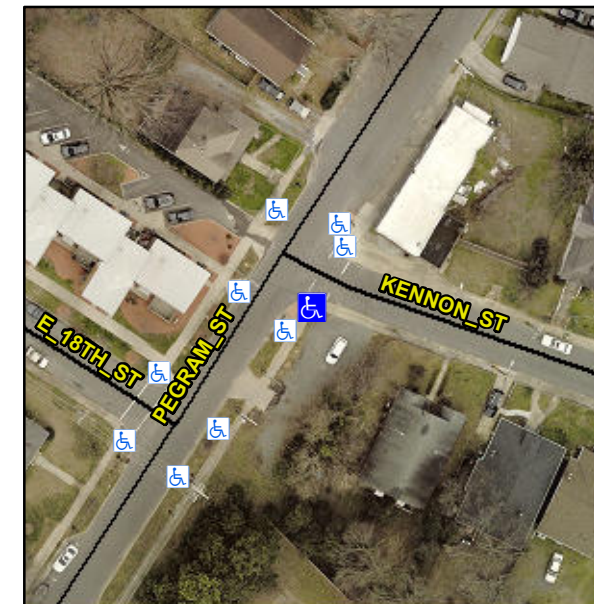
Compliance	Description	Data	Compliance	Description	Data
N/A	Ramp Length LT (in)	57.0	N/A	Ramp Length RT (in)	N/A
Yes	Ramp Width LT (in)	62.5	N/A	Ramp Width RT (in)	N/A
No	Ramp Slope LT (%)	9.8	N/A	Ramp Slope RT (%)	N/A
No	Ramp XSlope LT (%)	3.2	N/A	Ramp XSlope RT (%)	N/A
N/A	Landing Length (in)	N/A	N/A	DWS Provided?	N/A
N/A	Landing Width (in)	N/A	N/A	DWS Contrast?	N/A
N/A	Landing Slope (%)	N/A	N/A	DWS Length (in)	N/A
N/A	Landing X Slope (%)	N/A	N/A	DWS Full Width?	N/A
N/A	Landing Curb? (Y/N)	N/A	N/A	DWS Offset (in)	N/A
N/A	Shared Landing?	N/A			
N/A	Gutter Ponding?	N/A	N/A	Gutter Slope (%)	N/A
N/A	Gutter Lip Ht (in)	N/A	N/A	Gutter X Slope (%)	N/A
N/A	Painted X Walk1?	Yes	N/A	Painted X Walk2?	N/A
	X Walk 1 Direction	To NE		X Walk 2 Direction	N/A
N/A	X Walk 1 Width (in)	111.0	N/A	X Walk 2 Width (in)	N/A
	X Walk 1 Slope (%)	4.8		X Walk 2 Slope (%)	N/A
	X Walk 1 X Slope (%)	1.3		X Walk 2 X Slope (%)	N/A
N/A	Ramp inside XWalk1?	Yes	N/A	Ramp inside XWalk2?	N/A

Road Slope (%)	N/A	N/A	Clear Space?	N/A
	Road X Slope (%)	N/A	N/A	Clear Space to XWalk (in)	N/A
N/A	Any Obstructions?	N/A	N/A	Storm Grate/Utility Hazard?	N/A
	Obstruction Type			Storm Grate/Utility Type	
		N/A			N/A
			Yes	Surface Condition? (G/P)	Good
			N/A	Curb Slope (%)	12.4

Possible Solutions:

Remove & Replace Entire Ramp.
