Access Compliance Report

Public Rights-of-Way

(Curb Ramps)

Intersection ID: 52911	Main Street: CLEMS_CREEK_LN	Cross Street: CLEMS_CROSSING_DR	Location: E
ADA ID: 2538C0C3BAF8	Ramp Type: Directional1	Initial Pass/Fail: Pass	Overall Compliance: No
Severity Score: 0			
Codes/Mitigation Info/Possible Solution		Field Measurements/Component Compliance

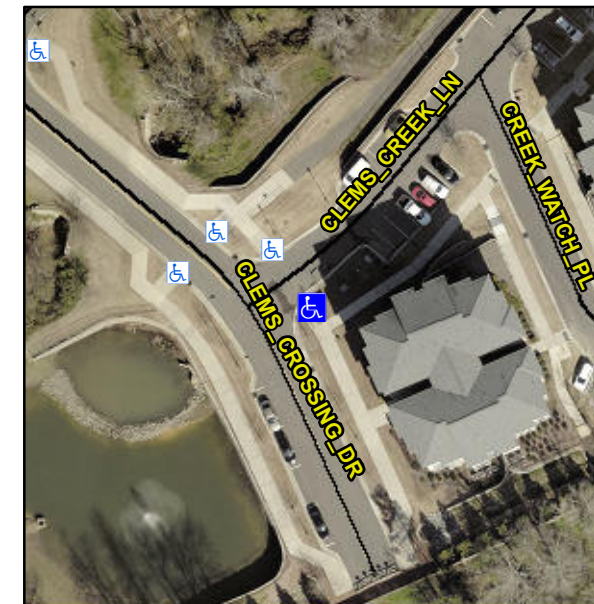
Compliance	Description	Data	Compliance	Description	Data
N/A	Ramp Length (in)	142.0	Yes	Grade Break?	Yes
Yes	Ramp Width (in)	97.0	Yes	Grade Break Slope (%)	2.8
Yes	Ramp Slope (%)	0.9	Yes	Grade Break XSlope (%)	1.6
Yes	Ramp XSlope (%)	0.2			
Yes	Flare Type LT	N/A	Yes	Flare Type RT	N/A
N/A	Flare Slope LT (%)	N/A	N/A	Flare Slope RT (%)	N/A
N/A	Flare Traversable LT?	No	N/A	Flare Traversable RT?	No
Yes	Landing Length (in)	75.0	Yes	DWS Provided?	Yes
Yes	Landing Width (in)	97.0	Yes	DWS Contrast?	Yes
No	Landing Slope (%)	4.7	Yes	DWS Length (in)	24.0
No	Landing X Slope (%)	2.1	Yes	DWS Full Width?	Yes
N/A	Landing Curb? (Y/N)	N/A	Yes	DWS Offset LT (in)	52.0
N/A	Shared Landing?	No	Yes	DWS Offset RT (in)	1.0
Yes	Gutter Ponding?	No	Yes	Gutter Slope (%)	0.9
Yes	Gutter Lip Ht (in)	0.0	Yes	Gutter X Slope (%)	0.0
N/A	Painted X Walk1?	No		Road Slope (%)	2.1
	X Walk 1 Direction	To NW		Road X Slope (%)	0.3
	X Walk 1 Width (in)	N/A		Clear Space?	Yes

X Walk 1 Slope (%)	2.1	N/A	Clear Space to XWalk (in)	N/A
	X Walk 1 X Slope (%)	0.3	Yes	Storm Grate/Utility Hazard?	No
N/A	Ramp inside XWalk1?	N/A		Storm Grate/Utility Type	
Yes	Any Obstructions?	No			N/A
	Obstruction Type		Yes	Surface Condition? (G/P)	Good
			N/A	Curb Slope (%)	7.9

Possible Solutions:

Remove & Replace Landing.

R304.2.2-Perp, R304.3.2-Para, R304.5.3

Total Cost: \$ 500.00
