# Access Compliance Report

## Public Rights-of-Way

### (Curb Ramps)

| Intersection ID: 27628 | Main Street: BALLANTYNE COMMONS PY | Cross Street: ADAIR MANOR CT | Location: SE |

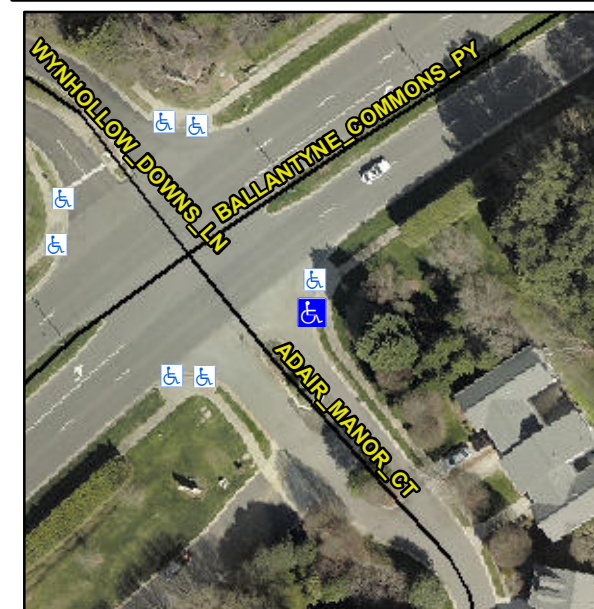
**Not Found, R304.2.2**

| Compliance | Description | Data | Compliance | Description | Data |
|---|---|---|---|---|---|
| N/A | Ramp Length (in) | 107.0 | No | Ramp Slope (%) | 9.3 |
| N/A | Painted X Walk1? | No | N/A | Painted X Walk2? | N/A |

**Remove & Replace Entire Ramp.**

Total Cost: \$ 1850.00
