# Access Compliance Report

## Public Rights-of-Way

### (Curb Ramps)

Intersection ID: 17481	Main Street: ALICIA_BRITTANY_LN	Cross Street: LYNWORTH_PL	Location: SE
ADA ID: 2551AB7EF027	Ramp Type: PerpDiag	Initial Pass/Fail: Fail	Overall Compliance: No
Severity Score: 21.25			
Codes/Mitigation Info/Possible Solution		Field Measurements/Component Compliance

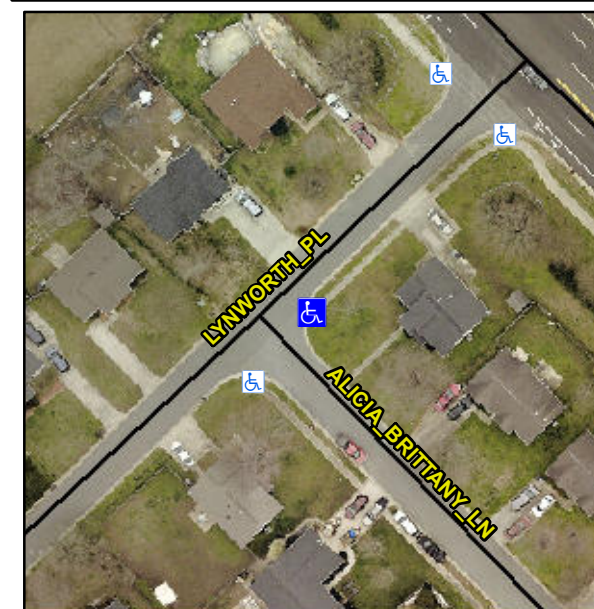
Compliance	Description	Data	Compliance	Description	Data
N/A	Ramp Length (in)	47.0	Yes	Ramp Slope (%)	6.5
No	Ramp Width (in)	38.0	No	Ramp XSlope (%)	6.8
N/A	Flare Type LT	N/A	N/A	Flare Type RT	N/A
N/A	Flare Slope LT (%)	N/A	N/A	Flare Slope RT (%)	N/A
N/A	Flare Traversable LT?	N/A	N/A	Flare Traversable RT?	N/A
N/A	Landing Length (in)	N/A	N/A	DWS Provided?	N/A
N/A	Landing Width (in)	N/A	N/A	DWS Contrast?	N/A
N/A	Landing Slope (%)	N/A	N/A	DWS Length (in)	N/A
N/A	Landing X Slope (%)	N/A	N/A	DWS Full Width?	N/A
N/A	Landing Curb? (Y/N)	N/A	N/A	DWS Offset (in)	N/A
N/A	Shared Landing?	N/A			
N/A	Gutter Ponding?	N/A	N/A	Gutter Slope (%)	N/A
N/A	Gutter Lip Ht (in)	N/A	N/A	Gutter X Slope (%)	N/A
N/A	Painted X Walk1?	No	N/A	Painted X Walk2?	No
	X Walk 1 Direction	To NW		X Walk 2 Direction	To SW
N/A	X Walk 1 Width (in)	N/A	N/A	X Walk 2 Width (in)	N/A
	X Walk 1 Slope (%)	8.2		X Walk 2 Slope (%)	1.2
	X Walk 1 X Slope (%)	1.5		X Walk 2 X Slope (%)	7.7

N/A	Ramp inside XWalk1?	N/A	N/A	Ramp inside XWalk2?	N/A
	Road Slope (%)	5.8	N/A	Clear Space?	N/A
	Road X Slope (%)	6.7	N/A	Clear Space to XWalk (in)	N/A
N/A	Any Obstructions?	N/A	N/A	Storm Grate/Utility Hazard?	N/A
	Obstruction Type			Storm Grate/Utility Type	
		N/A			N/A
			Yes	Surface Condition? (G/P)	Good

**Remove & Replace Curb Ramp With Two New Directional Ramps or Equivalent.**

**R304.5.1, R304.5.3**
