Access Compliance Report Public Rights-of-Way (Curb Ramps)

Intersection ID: 31892 Main Street: GREEN MOUNTAIN RD **Cross Street: LIFELINE LN** Location: NW Initial Pass/Fail: Fail **Overall Compliance: No Severity Score:** 10 ADA ID: 2588D00F10D0 Ramp Type: BlendTrans2

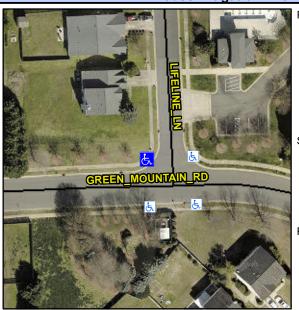
Ramp Length (in) Yes N/A 47.0 BlendTrans Slope (%) 3.9 No No Ramp Width (in) 45.0 BlendTrans XSlope (%) 3.4 N/A N/A Flare Type LT N/A Flare Type RT N/A N/A Flare Slope LT (%) N/A N/A Flare Slope RT (%) N/A N/A Flare Traversable LT? N/A N/A Flare Traversable RT? N/A N/A Landing Length (in) N/A N/A **DWS Provided?** N/A N/A Landing Width (in) N/A N/A **DWS Contrast?** N/A N/A N/A N/A Landing Slope (%) DWS Length (in) N/A N/A Landing X Slope (%) N/A N/A DWS Full Width? N/A N/A Landing Curb? (Y/N) N/A N/A DWS Offset (in) N/A N/A N/A Shared Landing? N/A **Gutter Ponding?** N/A N/A Gutter Slope (%) N/A N/A Gutter Lip Ht (in) N/A N/A Gutter X Slope (%) N/A N/A Painted X Walk1? No N/A Painted X Walk2? No X Walk 1 Direction To S X Walk 2 Direction To E N/A X Walk 2 Width (in) X Walk 1 Width (in) N/A X Walk 1 Slope (%) 2.6 X Walk 2 Slope (%) 2.4 X Walk 1 X Slope (%) 3.7 X Walk 2 X Slope (%) 2.3 N/A N/A Ramp inside XWalk2? N/A N/A Ramp inside XWalk1? Road Slope (%) 4.4 Clear Space? N/A N/A Road X Slope (%) 0.2 Clear Space to XWalk (in) N/A N/A N/A N/A Any Obstructions? Storm Grate/Utility Hazard? N/A **Obstruction Type** Storm Grate/Utility Type N/A N/A Yes Surface Condition? (G/P) Good N/A Curb Slope (%) 2.5

Street 1 Name **GREEN MOUNTAIN RD** Stop Condition-Street 1 None LIFELINE LN Street 2 Name Stop Condition-Street 2 StopSign Possible Solutions: Remove & Replace Curb Ramp With Two New Directional Ramps or Equivalent. Surveyor Notes: N/A PROW/ADA: R304.5.1, R304.5.3
