Access Compliance Report

Public Rights-of-Way

(Curb Ramps)

Intersection ID: N/A	Main Street: RIDGE_OAK_DR	Cross Street: OVERCUP_LN	Location: NW
ADA ID: 259021700DE3	Ramp Type: BlendTrans2	Initial Pass/Fail: Fail	Overall Compliance: No
		Severity Score: 8.75

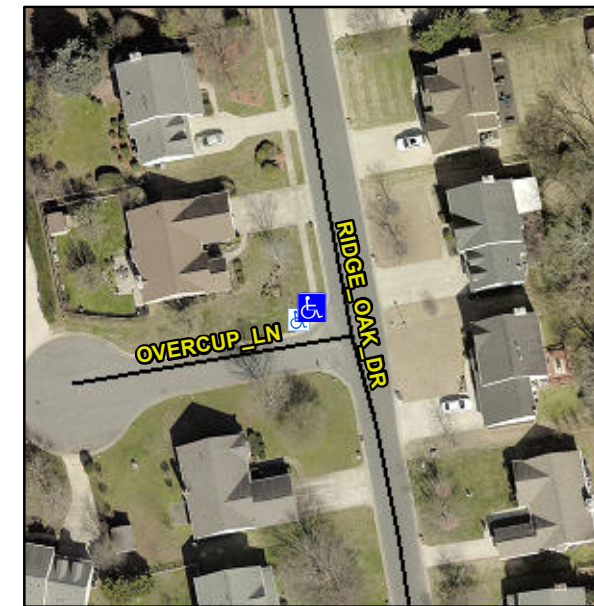
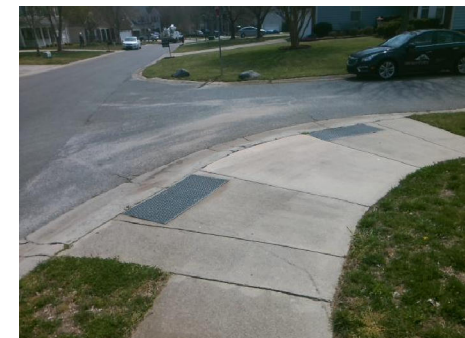
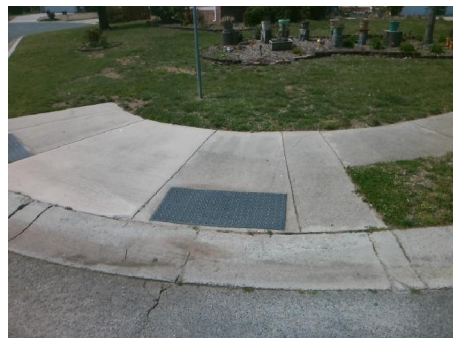
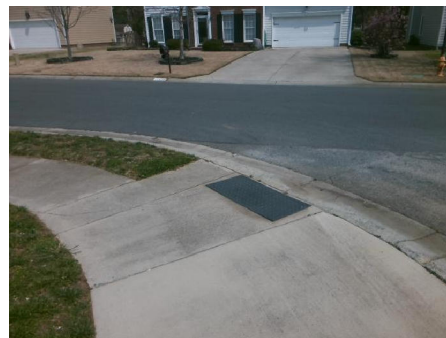
Not Found, R304.5.1

Compliance	Description	Data	Compliance	Description	Data
N/A	Ramp Length (in)	95.0	Yes	BlendTrans Slope (%)	3.8
No	Ramp Width (in)	38.0	Yes	BlendTrans XSlope (%)	0.2
N/A	Flare Type LT	N/A	N/A	Flare Type RT	N/A
N/A	Flare Slope LT (%)	N/A	N/A	Flare Slope RT (%)	N/A
N/A	Flare Traversable LT?	N/A	N/A	Flare Traversable RT?	N/A
N/A	Landing Length (in)	N/A	N/A	DWS Provided?	N/A
N/A	Landing Width (in)	N/A	N/A	DWS Contrast?	N/A
N/A	Landing Slope (%)	N/A	N/A	DWS Length (in)	N/A
N/A	Landing X Slope (%)	N/A	N/A	DWS Full Width?	N/A
N/A	Landing Curb? (Y/N)	N/A	N/A	DWS Offset (in)	N/A
N/A	Shared Landing?	N/A			
N/A	Gutter Ponding?	N/A	N/A	Gutter Slope (%)	N/A
N/A	Gutter Lip Ht (in)	N/A	N/A	Gutter X Slope (%)	N/A
N/A	Painted X Walk1?	No	N/A	Painted X Walk2?	N/A
	X Walk 1 Direction	To E		X Walk 2 Direction	N/A
	X Walk 1 Width (in)	N/A		X Walk 2 Width (in)	N/A
	X Walk 1 Slope (%)	1.6		X Walk 2 Slope (%)	N/A
	X Walk 1 X Slope (%)	0.1		X Walk 2 X Slope (%)	N/A

N/A	Ramp inside XWalk1?	N/A	N/A	Ramp inside XWalk2?	N/A
	Road Slope (%)	0.1		Clear Space?	N/A
	Road X Slope (%)	1.6	N/A	Clear Space to XWalk (in)	N/A
N/A	Any Obstructions?	N/A	N/A	Storm Grate/Utility Hazard?	N/A
	Obstruction Type			Storm Grate/Utility Type	
		N/A			N/A
			Yes	Surface Condition? (G/P)	Good
			No	Curb Slope (%)	6.9

Remove & Replace Curb Ramp With Two New Directional Ramps or Equivalent.

Total Cost: \$ 3200.00
