Access Compliance Report Public Rights-of-Way (Curb Ramps)

Intersection ID: 11958	Main Street: E_16TH_ST	Cross Street: SEIGLE_AV	Location: N
ADA ID: 2591007337D7	Ramp Type: Perp	Initial Pass/Fail: Fail	Overall Compliance: No Severity Score: 10

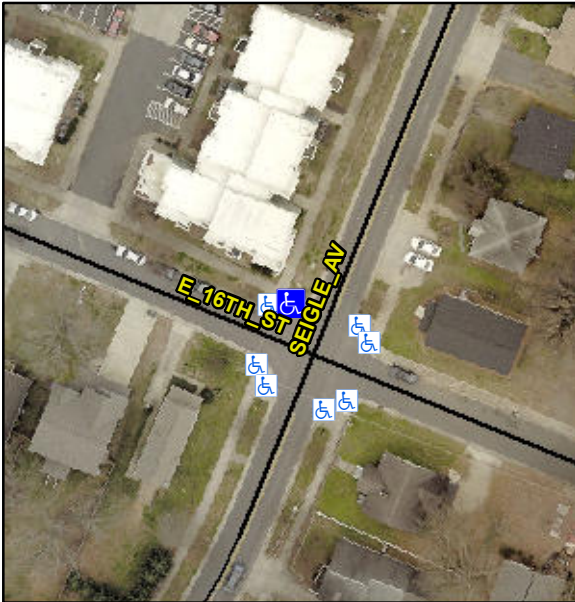
PROW/ADA:
R304.5.1, R304.5.3

Compliance	Description	Data	Compliance	Description	Data
N/A	Ramp Length (in)	75.0	Yes	Ramp Slope (%)	5.1
No	Ramp Width (in)	47.5	No	Ramp XSlope (%)	4.4
N/A	Flare Type LT	N/A	N/A	Flare Type RT	N/A
N/A	Flare Slope LT (%)	N/A	N/A	Flare Slope RT (%)	N/A
N/A	Flare Traversable LT?	N/A	N/A	Flare Traversable RT?	N/A
N/A	Landing Length (in)	N/A	N/A	DWS Provided?	N/A
N/A	Landing Width (in)	N/A	N/A	DWS Contrast?	N/A
N/A	Landing Slope (%)	N/A	N/A	DWS Length (in)	N/A
N/A	Landing X Slope (%)	N/A	N/A	DWS Full Width?	N/A
N/A	Landing Curb? (Y/N)	N/A	N/A	DWS Offset (in)	N/A
N/A	Shared Landing?	N/A			
N/A	Gutter Ponding?	N/A	N/A	Gutter Slope (%)	N/A
N/A	Gutter Lip Ht (in)	0.5	N/A	Gutter X Slope (%)	N/A
N/A	Painted X Walk1?	No	N/A	Painted X Walk2?	N/A
	X Walk 1 Direction	To SE		X Walk 2 Direction	N/A
N/A	X Walk 1 Width (in)	N/A	N/A	X Walk 2 Width (in)	N/A
	X Walk 1 Slope (%)	4.7		X Walk 2 Slope (%)	N/A
	X Walk 1 X Slope (%)	2.9		X Walk 2 X Slope (%)	N/A

N/A	Ramp inside XWalk1?	N/A	N/A	Ramp inside XWalk2?	N/A
	Road Slope (%)	N/A	N/A	Clear Space?	N/A
	Road X Slope (%)	N/A	N/A	Clear Space to XWalk (in)	N/A
N/A	Any Obstructions?	N/A	N/A	Storm Grate/Utility Hazard?	N/A
	Obstruction Type			Storm Grate/Utility Type	
			N/A		N/A
			Yes	Surface Condition? (G/P)	Good

Possible Solutions:
Remove & Replace Entire Ramp.
