Access Compliance Report

Public Rights-of-Way

(Curb Ramps)

Intersection ID: 10113	Main Street: LAKE_AV	Cross Street: RUSH_AV	Location: W
ADA ID: 259B950D2EFB	Ramp Type: Directional1	Initial Pass/Fail: Fail	Overall Compliance: No
			Severity Score: 13.75

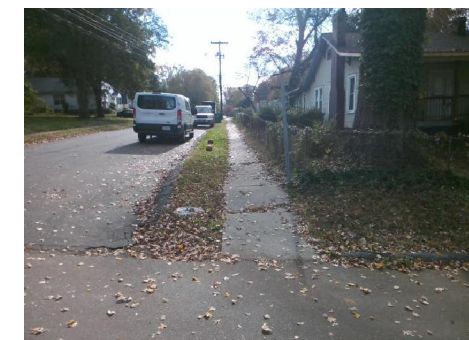
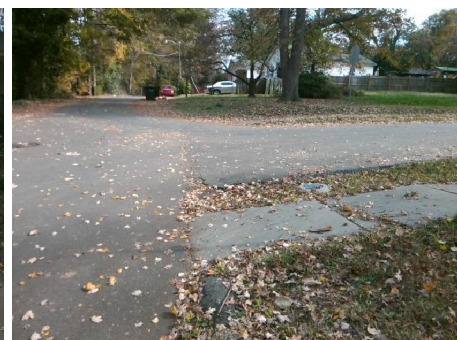
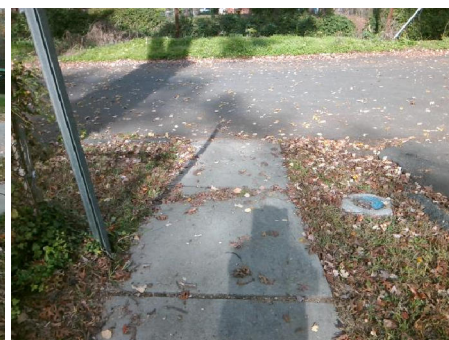
Possible Solutions:		Compliance			Description			Data			
	Remove & Replace Entire Ramp.		N/A	Ramp Length (in)		64.0		N/A	Grade Break?		N/A	
			Yes	Ramp Width (in)		48.0		N/A	Grade Break Slope (%)		0.0	
			No	Ramp Slope (%)		10.0		N/A	Grade Break XSlope (%)		0.0	
			No	Ramp XSlope (%)		2.3						
			N/A	Flare Type LT		N/A		N/A	Flare Type RT		N/A	
			N/A	Flare Slope LT (%)		N/A		N/A	Flare Slope RT (%)		0.0	
			N/A	Flare Traversable LT?		N/A		N/A	Flare Traversable RT?		N/A	
			N/A	Landing Length (in)		0.0		N/A	DWS Provided?		N/A	
			N/A	Landing Width (in)		0.0		N/A	DWS Contrast?		N/A	
		N/A	Landing Slope (%)		0.0		N/A	DWS Length (in)		N/A		
		N/A	Landing X Slope (%)		0.0		N/A	DWS Full Width?		N/A		
		N/A	Landing Curb? (Y/N)		N/A		N/A	DWS Offset LT (in)		N/A		
		N/A	Shared Landing?		N/A		N/A	DWS Offset RT (in)		N/A

N/A	Gutter Ponding?		0.0		N/A	Gutter Slope (%)		N/A		
		N/A	Gutter Lip Ht (in)		0.0		N/A	Gutter X Slope (%)		N/A		
		N/A	Painted X Walk1?		No			Road Slope (%)		1.9		
			X Walk 1 Direction		To E			Road X Slope (%)		5.7		
			X Walk 1 Width (in)		N/A			Clear Space?		N/A		
			X Walk 1 Slope (%)		1.9		N/A	Clear Space to XWalk (in)		N/A		
			X Walk 1 X Slope (%)		5.7		N/A	Storm Grate/Utility Hazard?		N/A		
		N/A	Ramp inside XWalk1?		N/A			Storm Grate/Utility Type				
		N/A	Any Obstructions?		N/A					N/A		
			Obstruction Type				Yes	Surface Condition? (G/P)		Good		
							N/A	Curb Slope (%)		N/A
