# Access Compliance Report

## Public Rights-of-Way

| Intersection ID: N/A | Main Street: GARDNER_LN | Cross Street: ALEXANDER_CREST_LN | Location: NW |
| ADA ID: 259CFFEAD426 | Ramp Type: PerpDiag | Initial Pass/Fail: Fail | Overall Compliance: No |

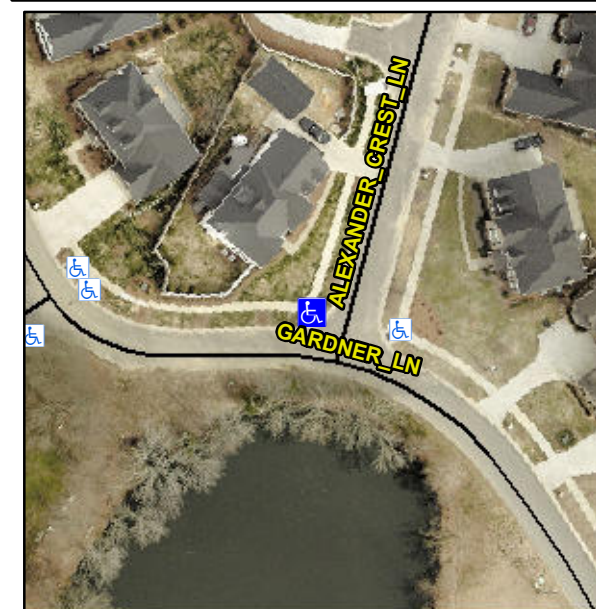
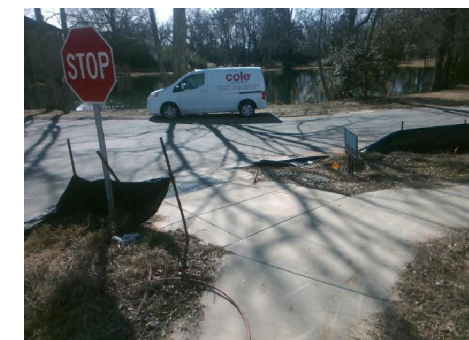
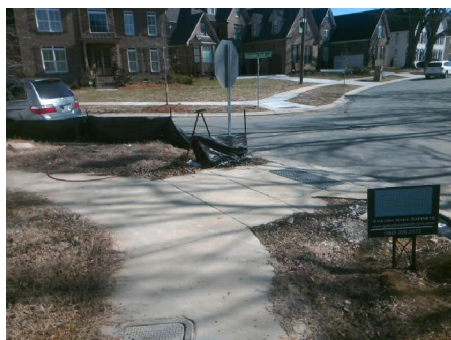
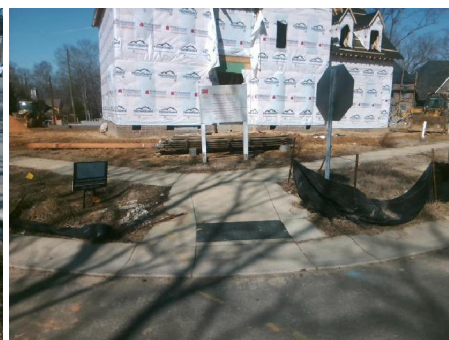
**Not Found, R304.2.2, R304.5.3**

| Compliance | Description | Data | Compliance | Description | Data |
|---|---|---|---|---|---|
| N/A | Ramp Length (in) | 97.0 | No | Ramp Slope (%) | 8.9 |
| Yes | Ramp Width (in) | 48.0 | No | Ramp XSlope (%) | 3.1 |

**Remove & Replace Curb Ramp With Two New Directional Ramps or Equivalent.**

Total Cost: \$ 3200.00
