# Access Compliance Report

## Public Rights-of-Way

### (Curb Ramps)

Intersection ID: 12636	Main Street: BENTLEY_PL	Cross Street: EASTWAY_DR	Location: NW
ADA ID: 25B44719CBCA	Ramp Type: Perp	Initial Pass/Fail: Fail	Overall Compliance: No
Severity Score: 25			
Codes/Mitigation Info/Possible Solution		Field Measurements/Component Compliance

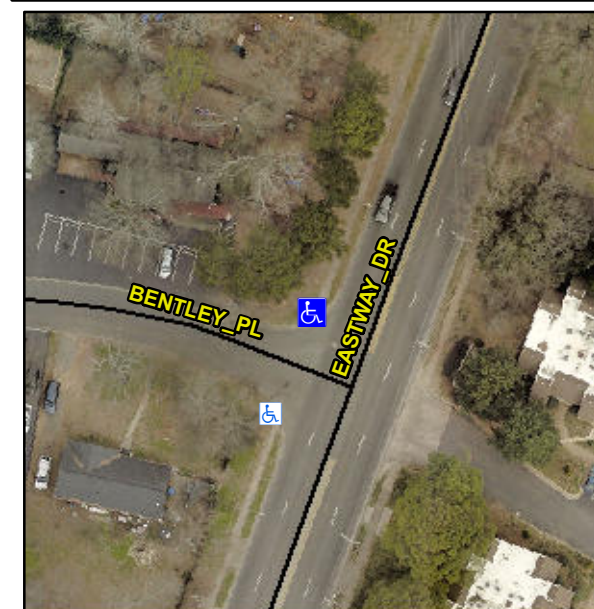
**Not Found, R304.2.2**

Compliance	Description	Data	Compliance	Description	Data
N/A	Ramp Length (in)	48.0	No	Ramp Slope (%)	13.1
Yes	Ramp Width (in)	48.0	Yes	Ramp XSlope (%)	1.3
N/A	Flare Type LT	N/A	N/A	Flare Type RT	N/A
N/A	Flare Slope LT (%)	N/A	N/A	Flare Slope RT (%)	N/A
N/A	Flare Traversable LT?	N/A	N/A	Flare Traversable RT?	N/A
N/A	Landing Length (in)	N/A	N/A	DWS Provided?	N/A
N/A	Landing Width (in)	N/A	N/A	DWS Contrast?	N/A
N/A	Landing Slope (%)	N/A	N/A	DWS Length (in)	N/A
N/A	Landing X Slope (%)	N/A	N/A	DWS Full Width?	N/A
N/A	Landing Curb? (Y/N)	N/A	N/A	DWS Offset (in)	N/A
N/A	Shared Landing?	N/A			
N/A	Gutter Ponding?	Yes	N/A	Gutter Slope (%)	N/A
N/A	Gutter Lip Ht (in)	N/A	N/A	Gutter X Slope (%)	N/A
N/A	Painted X Walk1?	No	N/A	Painted X Walk2?	N/A
	X Walk 1 Direction	To SW		X Walk 2 Direction	N/A
N/A	X Walk 1 Width (in)	N/A	N/A	X Walk 2 Width (in)	N/A
	X Walk 1 Slope (%)	0.2		X Walk 2 Slope (%)	N/A
	X Walk 1 X Slope (%)	2.2		X Walk 2 X Slope (%)	N/A

Possible Solutions:

**Remove & Replace Entire Ramp.**
